The Australasian Corrosion Association Inc. Corrosion Challenges Project

A report on the impact of failure of infrastructure assets through corrosion as a result of current practices and skilling in the Australian mainland urban water and Naval defence sectors.

Terms of Reference and Sector Reports

CORROSION CHALLENGES - URBAN WATER INDUSTRY

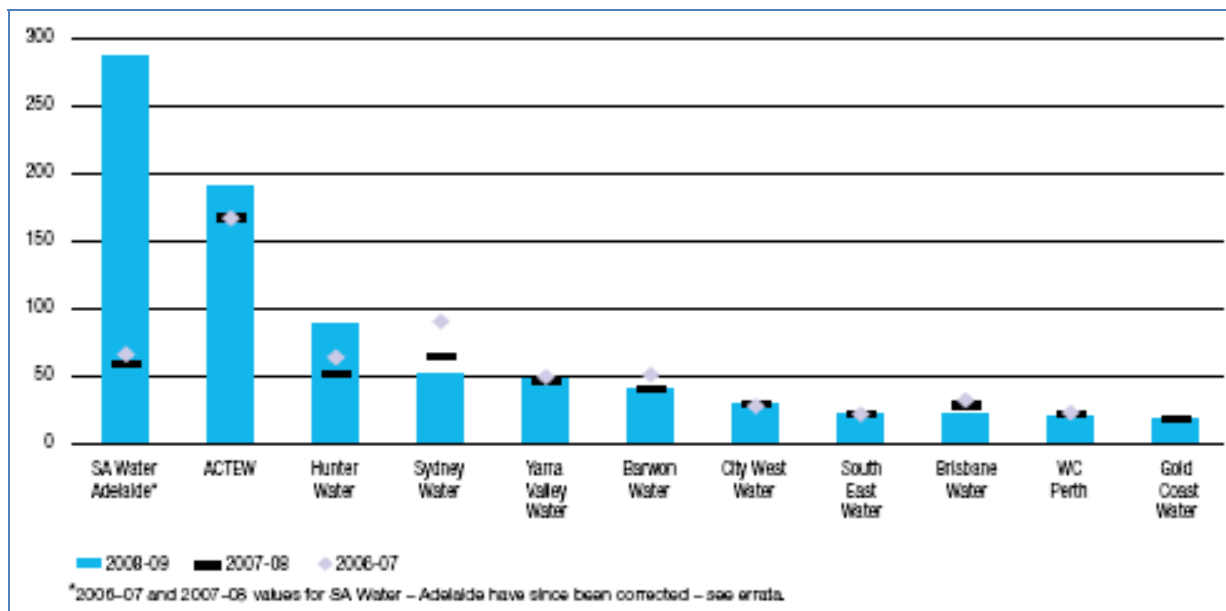
Graph 4 – Number of sewer chokes and breaks per 100 km of sewer mains per year

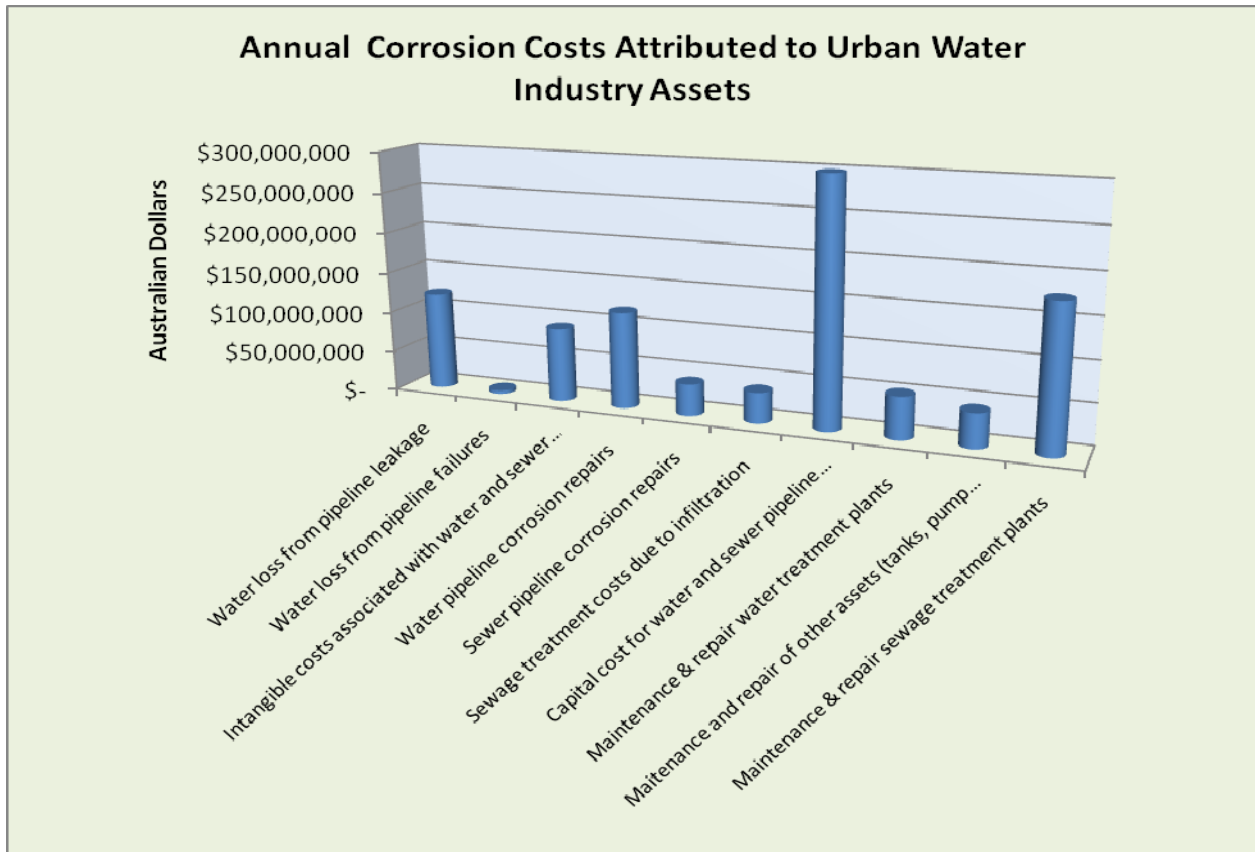
Graph 7 – Annual corrosion costs attributed to urban Water Industry assets

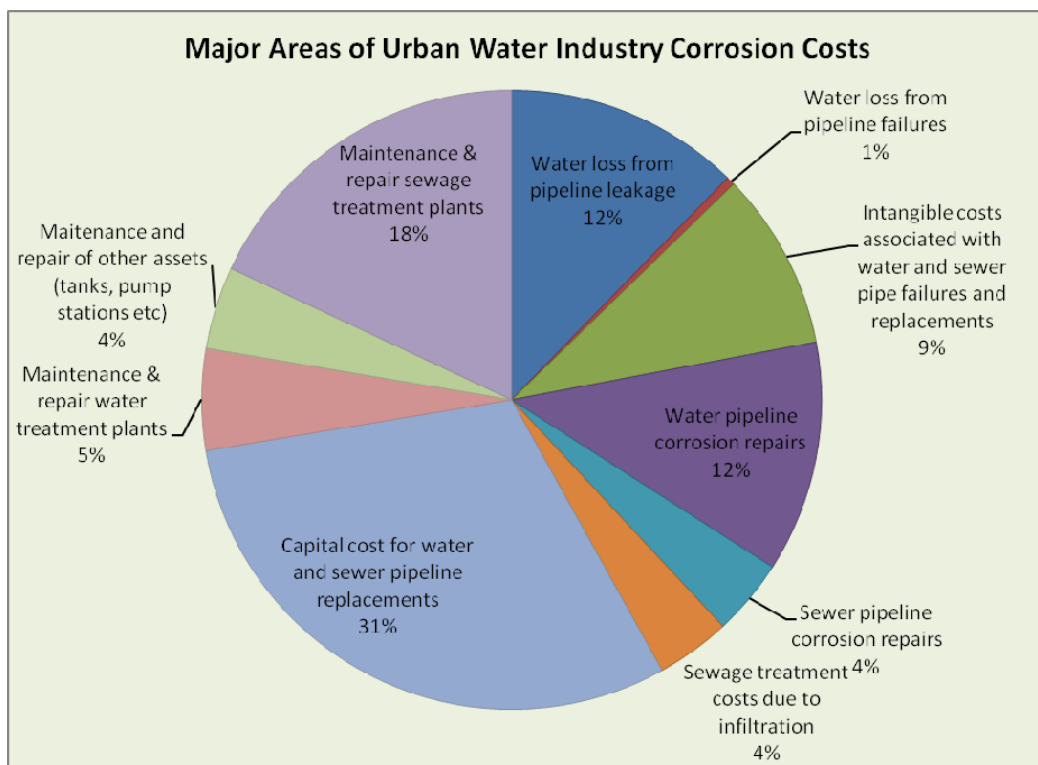
Graph 8 – Major areas of urban Water Industry corrosion costs

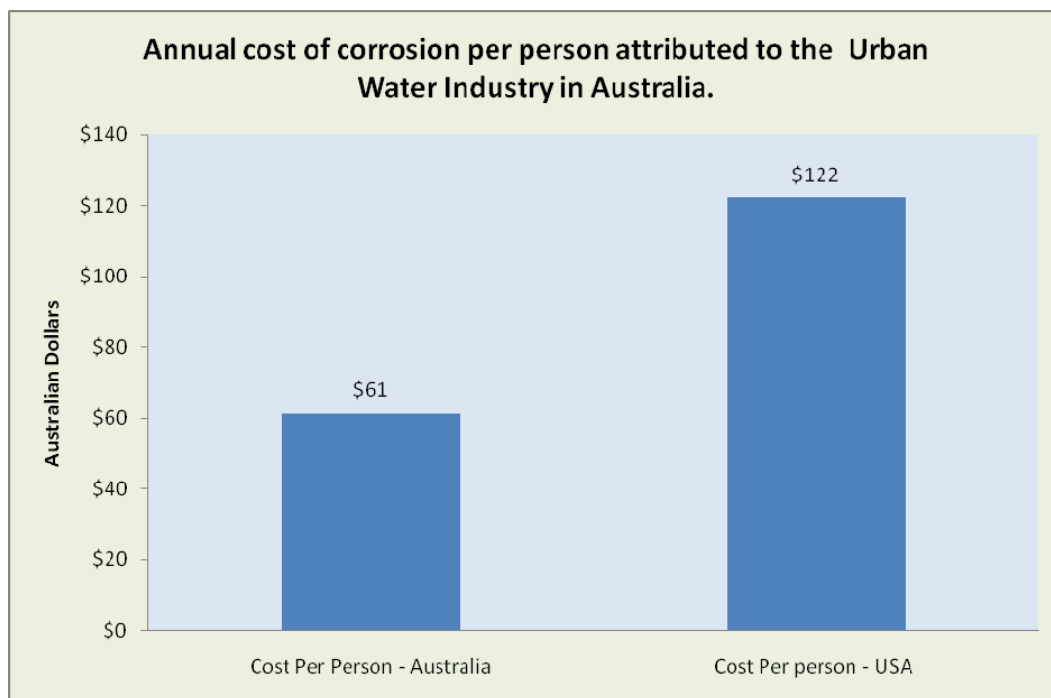
Graph 9 – Per capita corrosion cost comparisons

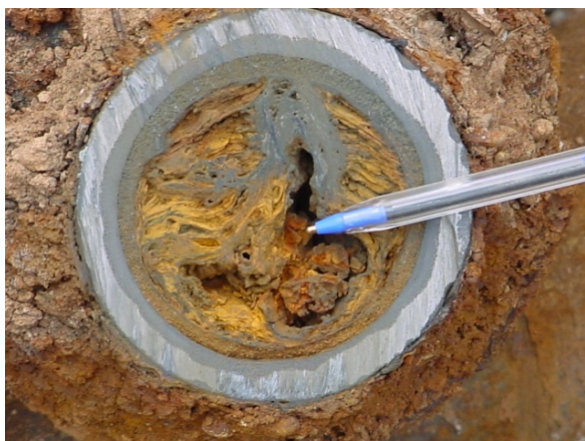
Figure A1 Internal corrosion of an unlined cast iron pipe

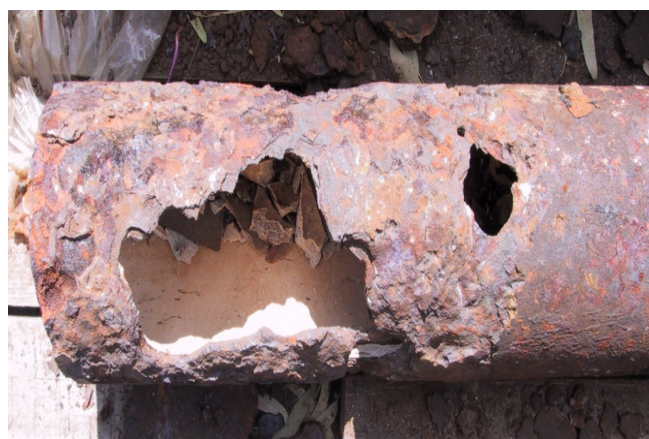
Figure A2 External corrosion of cast iron pipe

External corrosion is by far the most prevalent form of failure of cast iron pipe (Figure A2) due largely to corrosive soils, but the thick walls of the early vertical or horizontally sand cast pipes provided in many cases a large corrosion allowance which afforded longevity of life which otherwise would not have been the case. Some of these pipes with only the original bitumen external coating are still in use today after 100+ years of service, but these are generally in areas of low soil corrosivity and are probably the minority at this point in time. The introduction of spun cast iron pipes in 1929 in a steel mould process resulted in thinner pipe walls. The absence of a high silica surface layer formed in the sand casting process which anecdotally provides greater corrosion protection was also removed with the introduction of spun cast iron pipe.

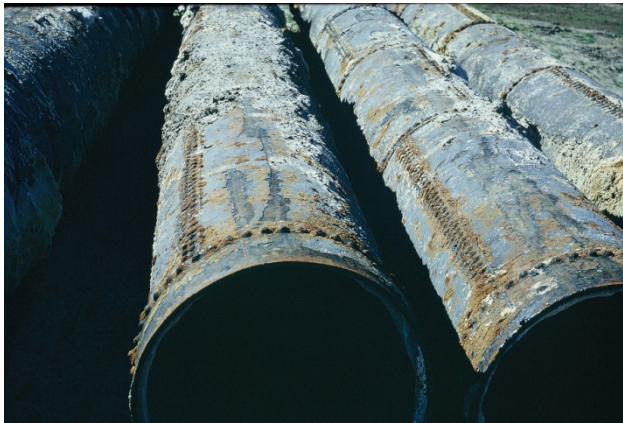
Figure A3 Riveted steel pipe

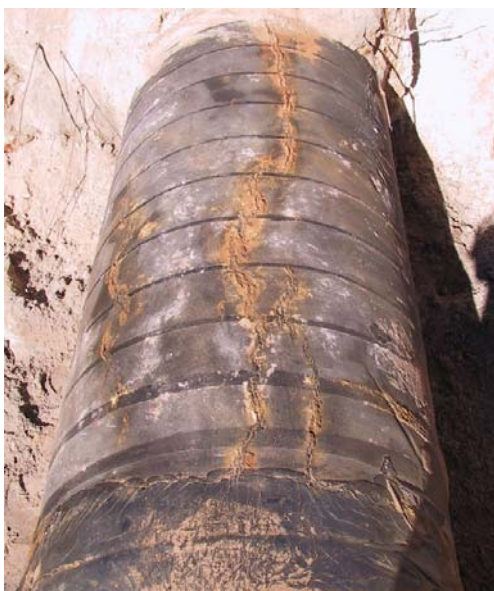
Figure A5

Longitudinal splitting of coal tar enamel external coating exposing the underlying steel to external corrosion

While steel has been used for over 100 years, today's steel pipe has had many improvements and developments in corrosion protection, and in recent times has provided the industry with a high performance product. Fully welded steel pipe, externally coated with fusion bonded polyethylene and centrifugally lined with cement mortar lining, can provide the 100 year life as demanded by the industry. Some manufactures have recently promoted epoxy or other organic linings as an alternative to cement mortar lining, but these will not provide the long term performance required by the Water Industry. Prior to the introduction of fusion bonded polyethylene, external coatings of reinforced coal tar enamel were widely used. While this provided improvements over the very early tar and bitumen coatings, it was susceptible to deterioration; particularly by soil stresses which resulted in splitting of the coatings and subsequent exposure of the steel to soil corrosion as shown Figure A5.

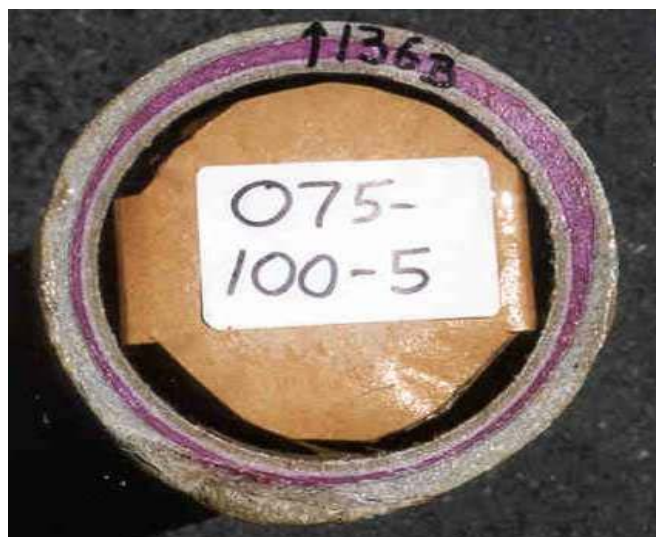
Figure A6

Cross section of AC pipe showing internal and external deterioration. Un-deteriorated portions of AC show up as the coloured areas. (Courtesy Opus International Consultants)

The common method used to assess the depth of deterioration or degradation of an AC pipe wall is staining with phenolphthalein indicator^{5,7}. Phenolphthalein is a weak acid indicator that changes to a progressively deeper magenta colour from a pH of 8.3 to 10.0. This colour change can be used to highlight the difference between the alkaline areas, where the cement matrix is sound, and the lower pH areas where the Ca(OH)_2 has been leached away (Figure A6).

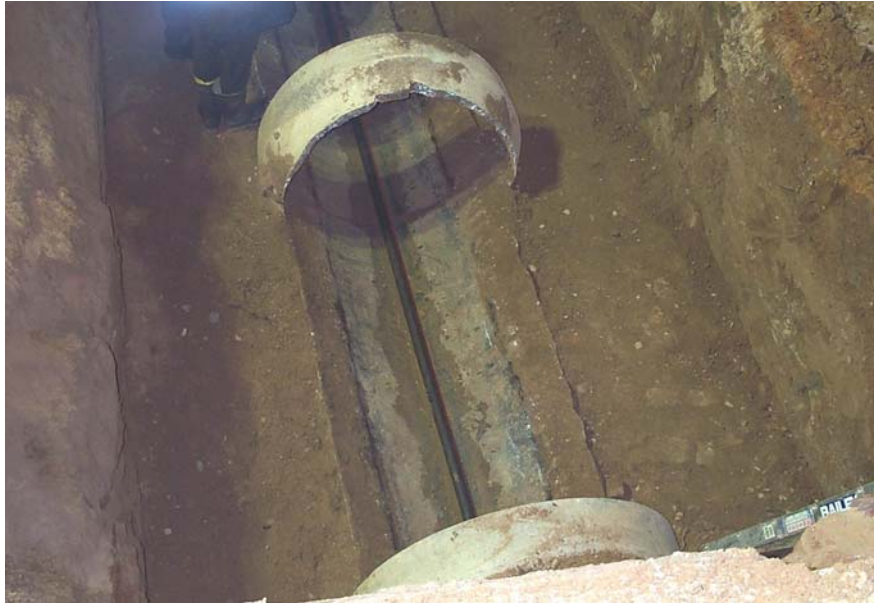
Figure A7 - Relining of a corroded reinforced concrete sewer pipes shows the crown of the pipe has been severely corroded leaving only the base of the pipe and the collars at the joints where they were provided with some protection by the spigot of the other pipe.

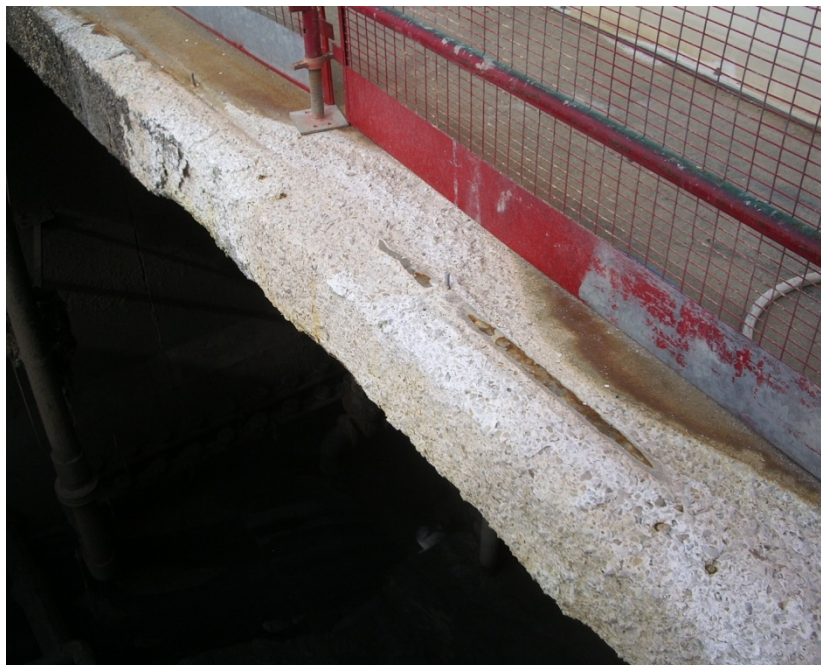
Figure A8 - Severe corrosion of concrete in an aeration tank covered to reduce odours. The corrosion was up to 75mm in 3- 4 years despite the use of an extraction system.

Reinforced concrete pipes are used for some pressure applications but these are a minority compared to non-pressure sewer pipes. In most cases conventional reinforced concrete pipes manufactured with normal Portland cement were used, but in some areas calcareous aggregate was used to allow for a more uniform corrosion rate of the concrete. Hydrogen sulphide is particularly aggressive to concrete and severe corrosion can result in the vapour zone or the crown of the pipe (Figure A7). Ultimately the corrosion can be such that the structural strength of the pipe is severely compromised which usually ends in a collapsed sewer. Similarly, where odour control initiatives have been introduced in sewage treatment plants by covering tanks, very severe concrete corrosion can result (Fig A8).

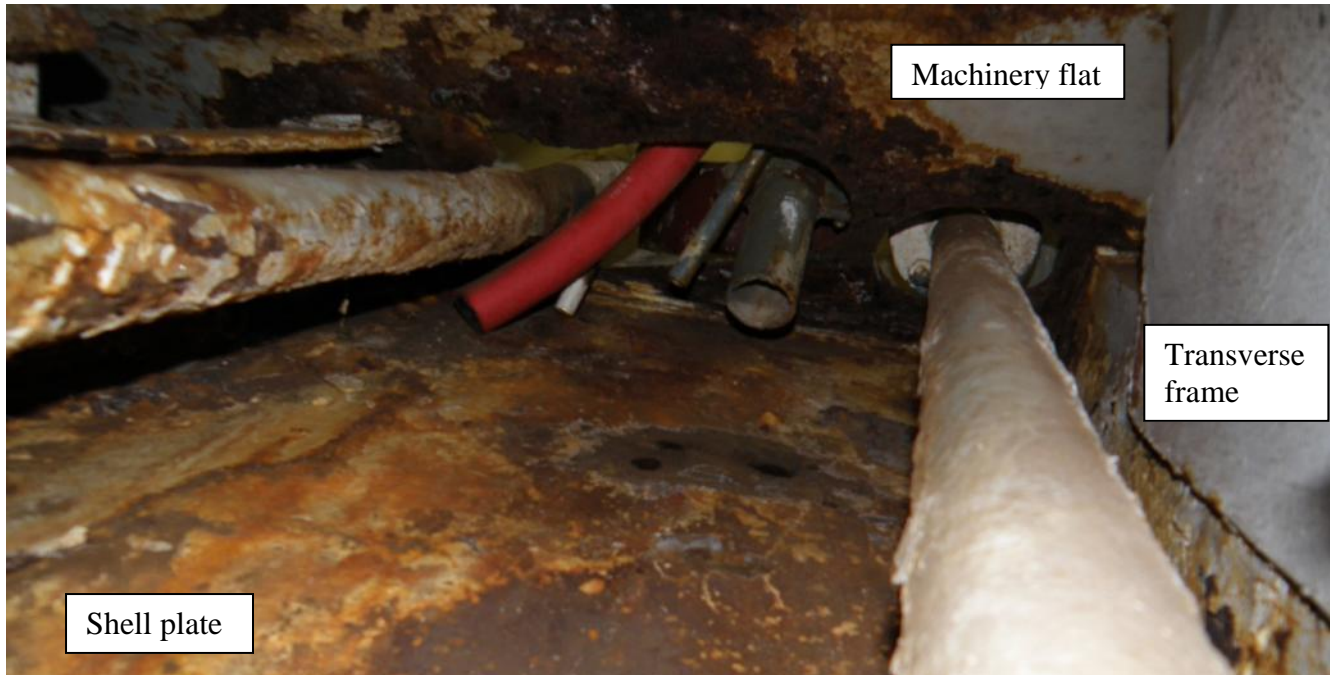
- Structural Function:** Hull shell plating and machinery support platform.
- Corrosion Protection:** Protective coating.
- Damage Susceptibility:** Corrosion from bilge lines draining directly onto shell plate.
- Planned Maintenance:** 60 month survey interval.
- Damage:** Whilst repairs to the Aft Peak Tank were being undertaken, further deep corrosion of shell plating was evident underneath a machinery flat in the Auxiliary Machinery Room. Detailed inspection and thickness testing showed corrosion in excess of 50% NPT with the subsequent plate renewal extending the duration of the unscheduled docking period. Figure 4 shows the underside of the machinery flat, the related piping and shell plating. The cause of corrosion was attributed to drain lines plumbed under the deck, out-letting directly onto the shell plate and not into a drain tank.

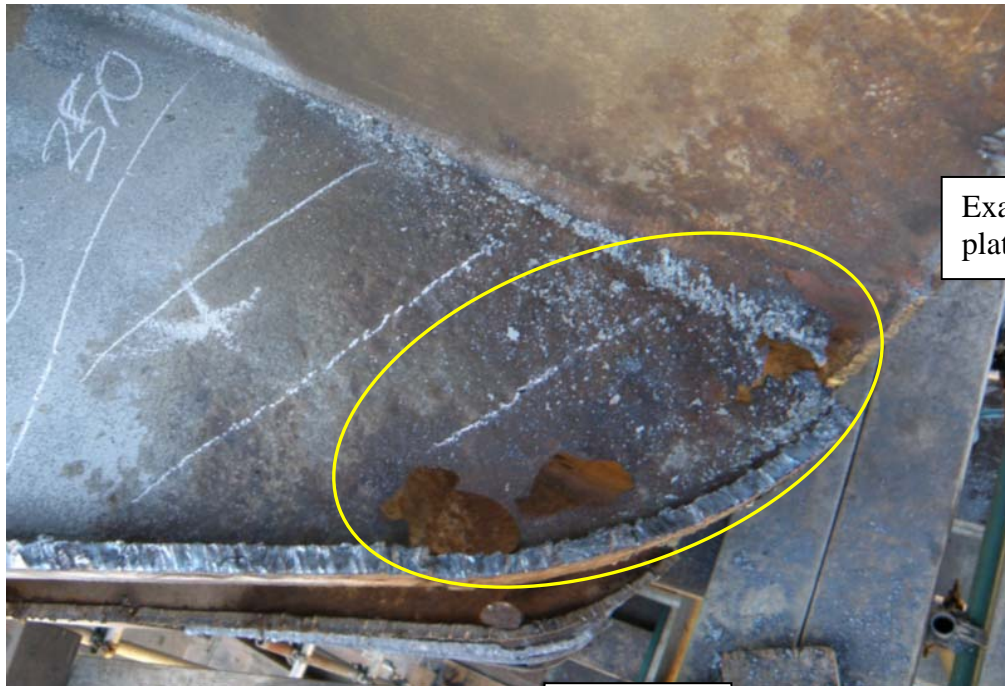
An accumulation of debris and visible corrosion around the site of debris lead to conducting a thickness test of the shell plate. Readings indicated localised wastage in excess of 50% NPT, with general wastage between 30-50%. A resurvey undertaken after the thickness testing indicated a high risk of excessive corrosion to internal stiffeners. The extent of wastage necessitated immediate repair due to the resultant loss of strength in the bow region. Once plating was cropped away, cleaning of internal framing revealed extensive deep wastage of web frames with some sections holed (Figure 7); a total of 8 web frames required repair on both the port and starboard sides of the bow, together with approximately 12m² of shell plate. Figure 7 shows how localised and severe the corrosion was, with the section marked up to be cropped back 350mm.

Example of internal web plate corroded & holed
