# CORROSION

Vol 46 No. 2

**April 2025**  
***In this issue:***

**FEATURE:  
CONCRETE STRUCTURES**

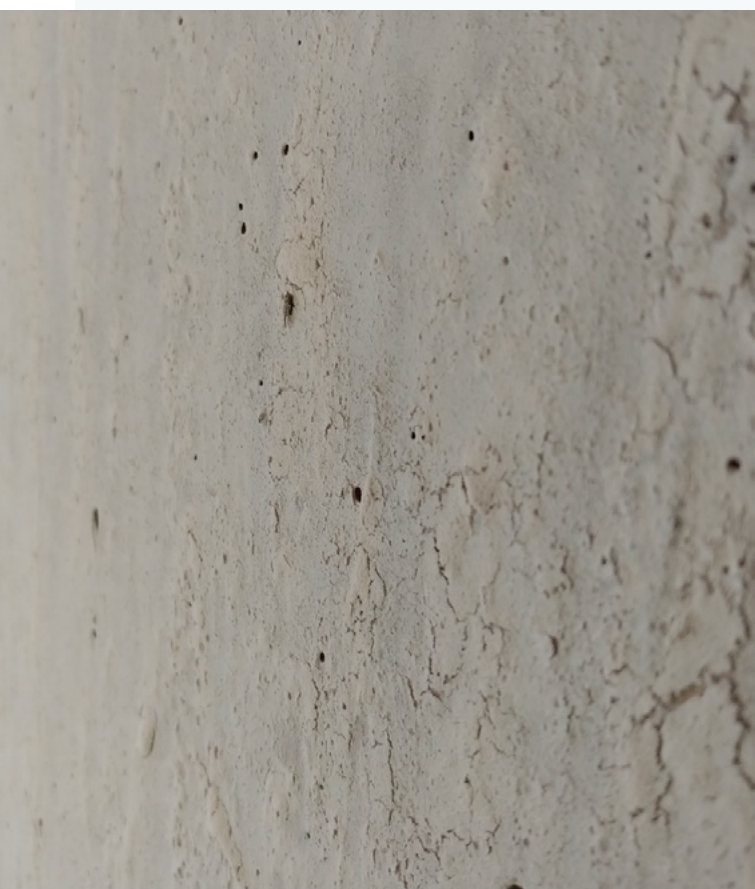
*Figure 1: Dried residues of a Penkal Realkalization Solution application undertaken to a carbonated concrete wall prior to its washing off.*

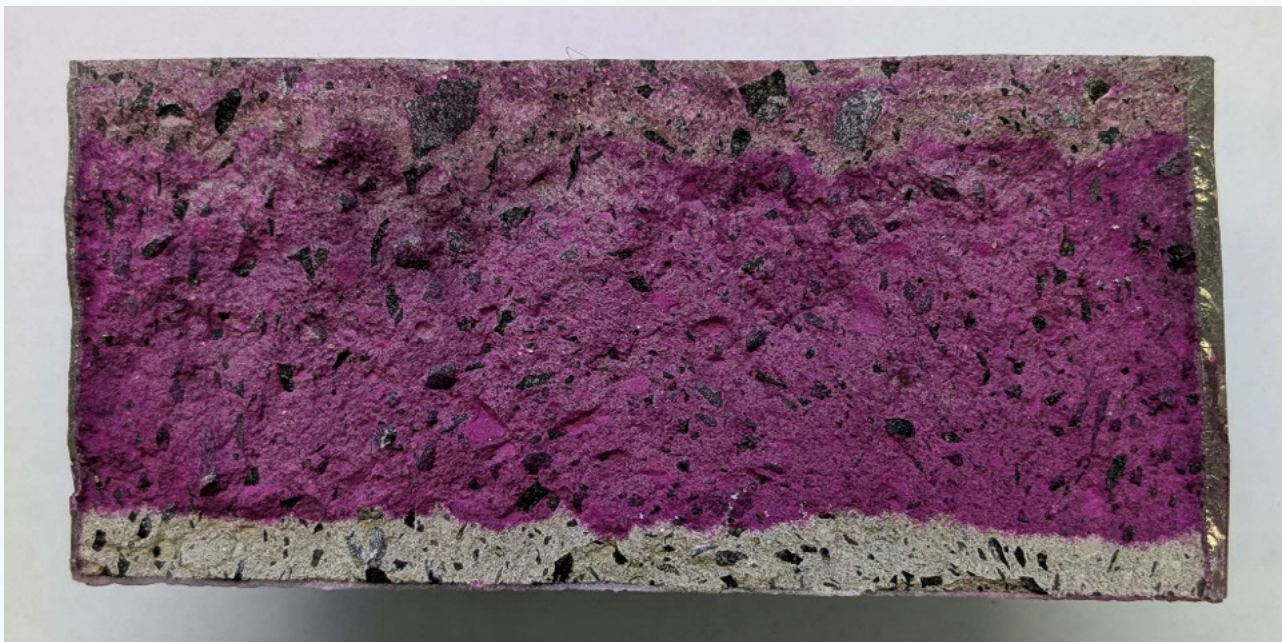
(Above) Figure 3: Cross-section of concrete sample treated with the Realkalization Solution on top section following accelerated carbonation testing for 8 weeks. Light colouration indicates carbonated concrete which maintains high alkalinity (measured as pH 11.4 by ground sample leaching method), while darker areas indicate non-carbonated concrete.

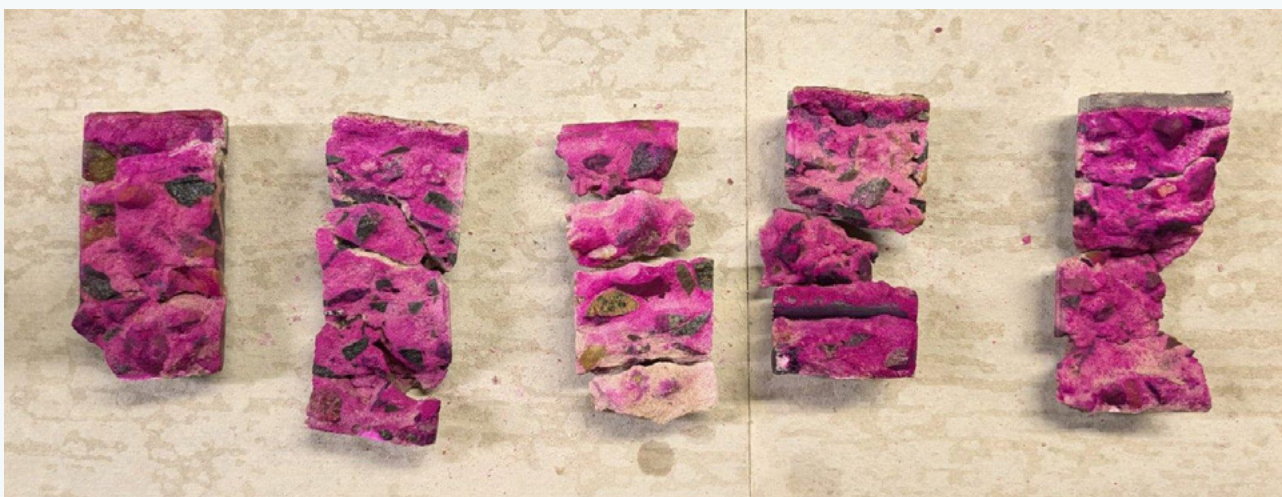
(Below): Figure 4: Core samples obtained following Realkalization Solution application to a concrete slab recording carbonation depths of >45mm to fully carbonated following shortened 1 month treatment time before coring. Indicator colour change from 60mm to fully realkalized core samples.

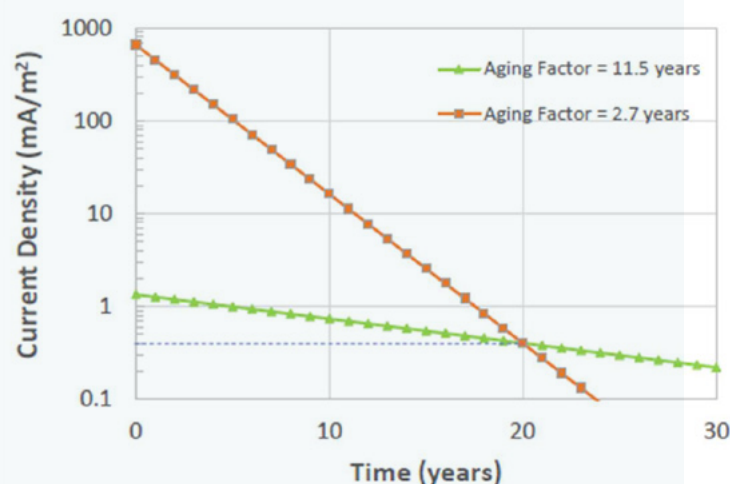
Figure 1: Current density vs time for two hypothetical

anode systems with different initial current density outputs and aging-factors such that both anodes provide a minimum current density of 0.4 Ma/m<sup>2</sup> over a 20 year service life.

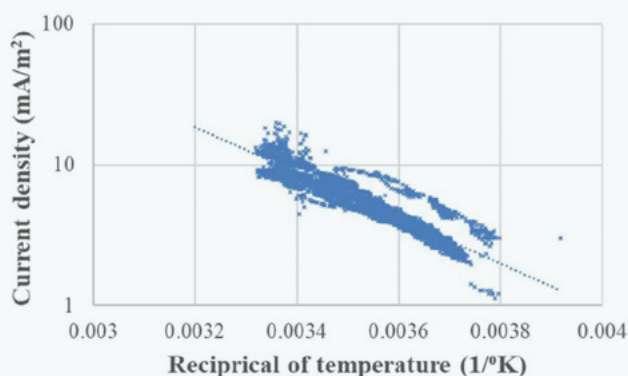
Figure 2: Variation of current output of galvanic anodes with concrete temperature in a bridge abutment, Ohio, USA.

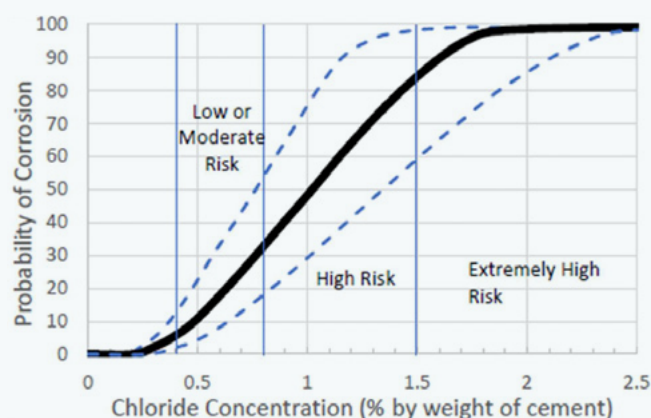
Figure 3: Corrosion risk categorization for steel reinforcement in concrete. (Concrete society tr 73, 2011, bre Digest 444 part-2, 2000)

The increase in corrosion risk as a function of increased levels of chloride in the vicinity of the steel, is consistent with Concrete Society TR73 [4] and BRE Digest 444 [5] as illustrated in Fig. 3. The doubling of the current requirement for every step increase in corrosion risk is shown in Table 1.

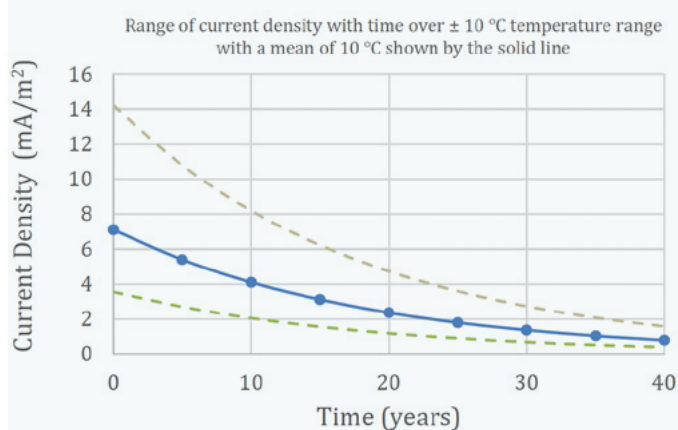
Figure 7: Current density vs time for the das anodes considered in the model.

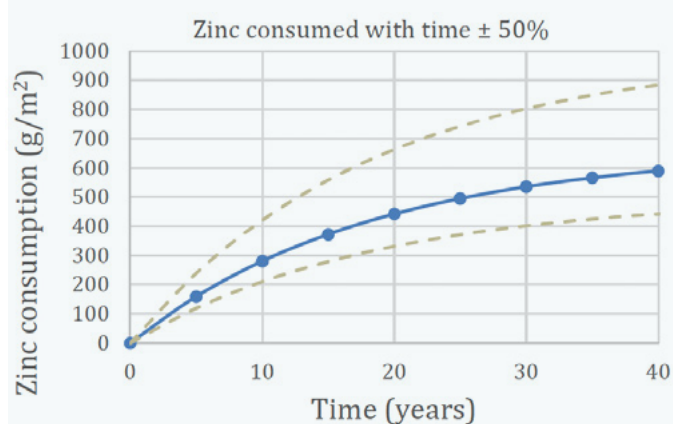
Figure 8: Zinc consumption vs time for the das anodes considered in the model.

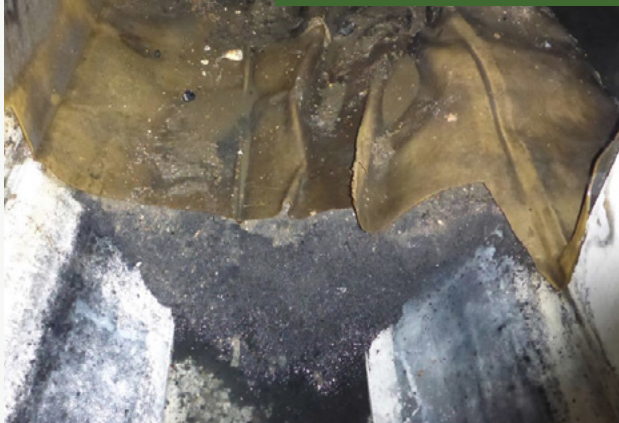
*Failed Pure Polyurea linings at Mackay North Water Recycling Facility.*

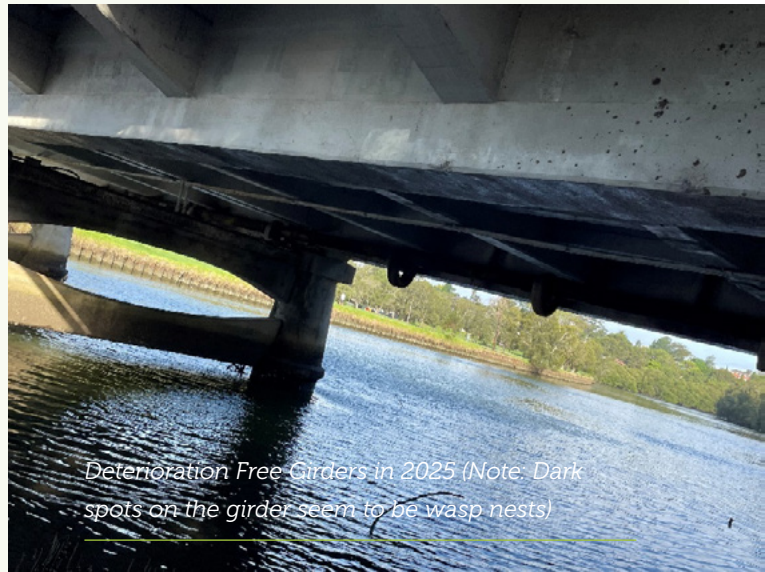
*Deterioration Free Girders in 2025 (Note: Dark spots on the girder seem to be wasp nests)*

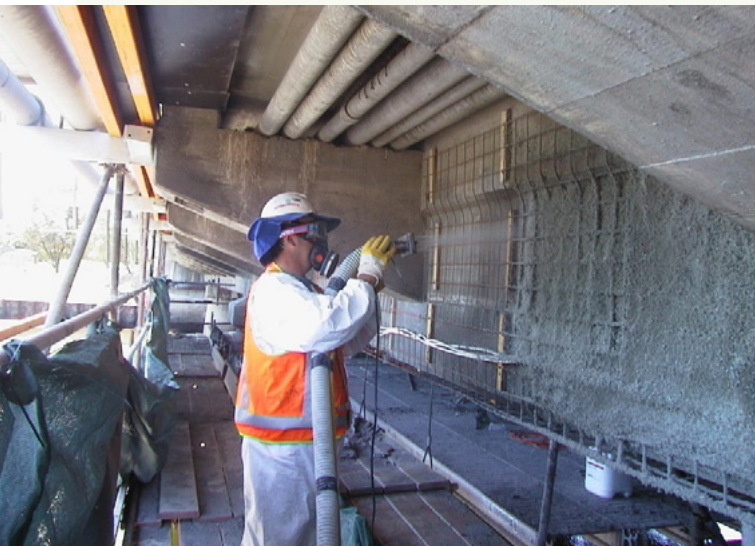
*An Operator Applying Re-alkalisation to the Bridge (Photo circa 2001)*

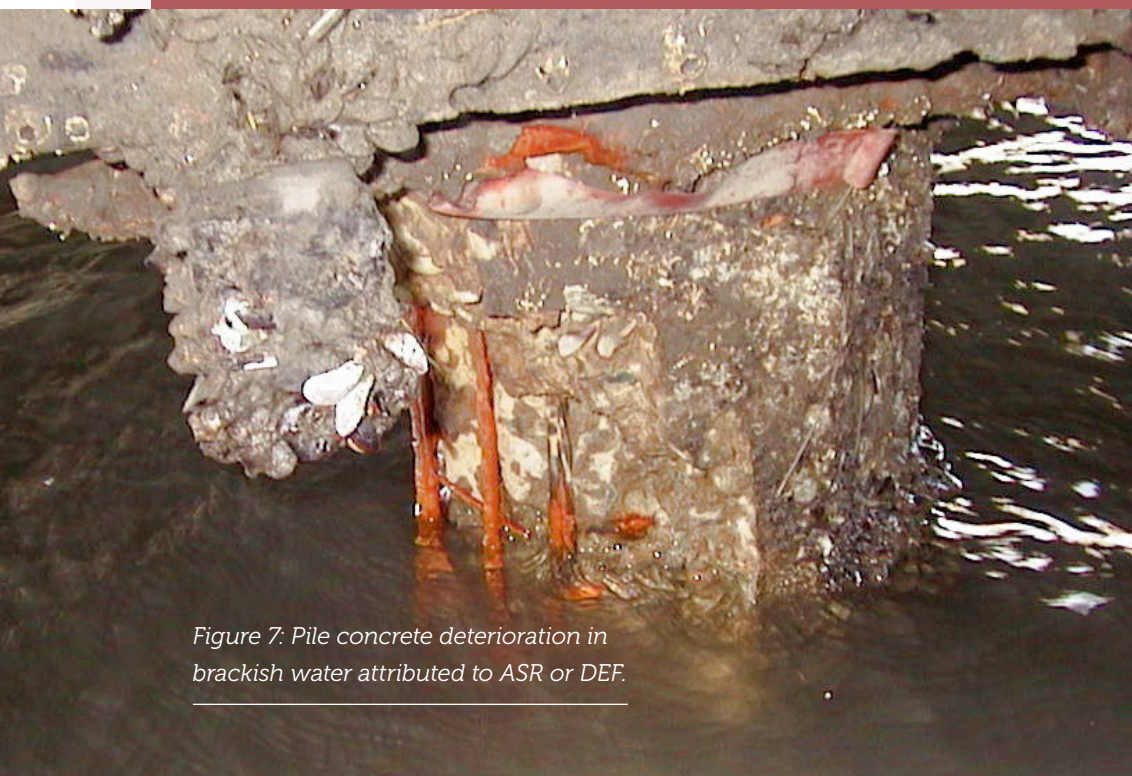
Figure 7: Pile concrete deterioration in brackish water attributed to ASR or DEF.
