CORROSION

Vol 46 No. 3

July 2025 In this issue:

**FLOWING FORWARD: INNOVATION & SUSTAINABILITY
IN WATER & WASTEWATER INFRASTRUCTURE**

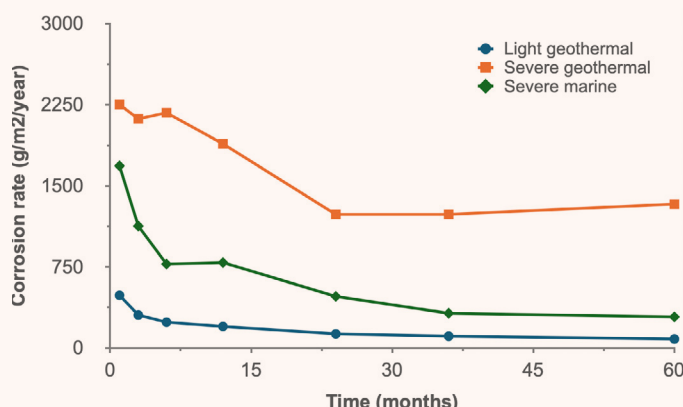
The corrosion rates of carbon steel samples measured within this 5-year exposure are shown in Figure 1.

Figure 1. Corrosion rates of carbon steel measured at three exposure sites.

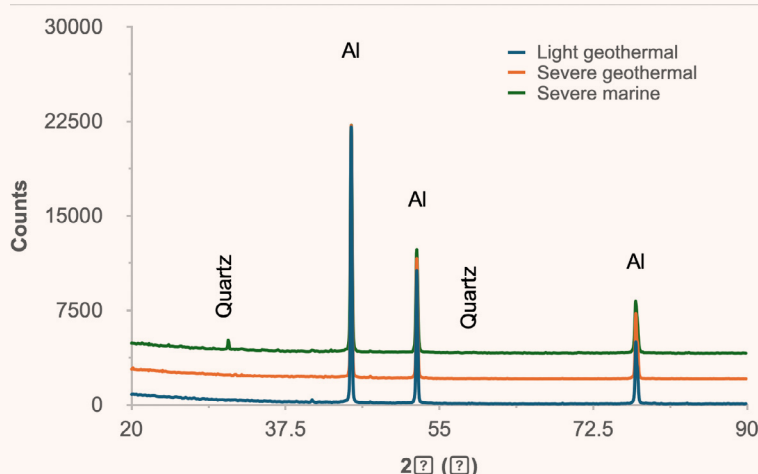
XRD analysis shows that the predominant constituent in the TSA coating samples after a 5-year exposure in geothermal and marine environments is aluminium (Figure 12). This is basically the same as when the TSA coatings were prepared. That said, oxygen and/or sulphur had found their way into the coating through pores, cracks and other physical defects, but these interactions with aluminium were still slow and limited within this field exposure. This is consistent with SEM morphological characterisations and EDS elemental mapping done on the top surfaces and from cross-sections.

Figure 12. XRD pattern of TSA coatings after 5-year exposure in geothermal and severe marine environments.

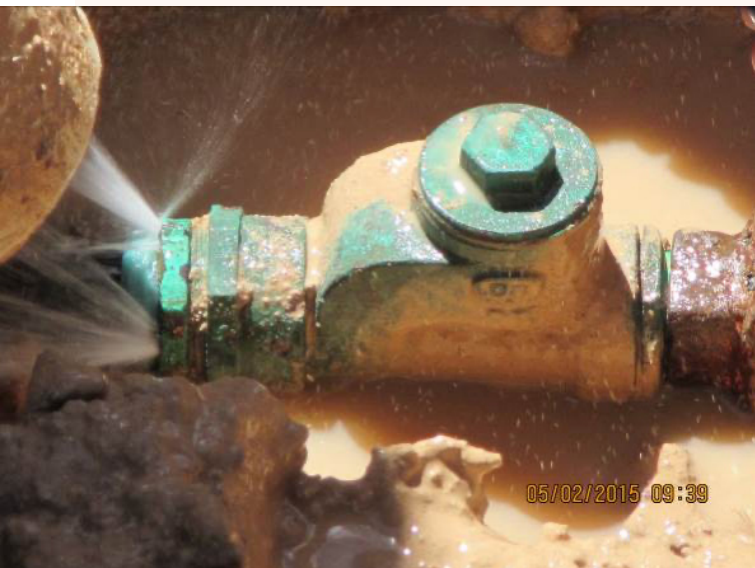
are already developing signs of premature failure. Data supplied shows that even with relatively new installations there are over 300 failures in a period of two years; the majority of these being leaks at the ferrule. Figure 3 below shows such a failure.

Figure 3: Leakage of PE main-to-meter connection at ferrule.

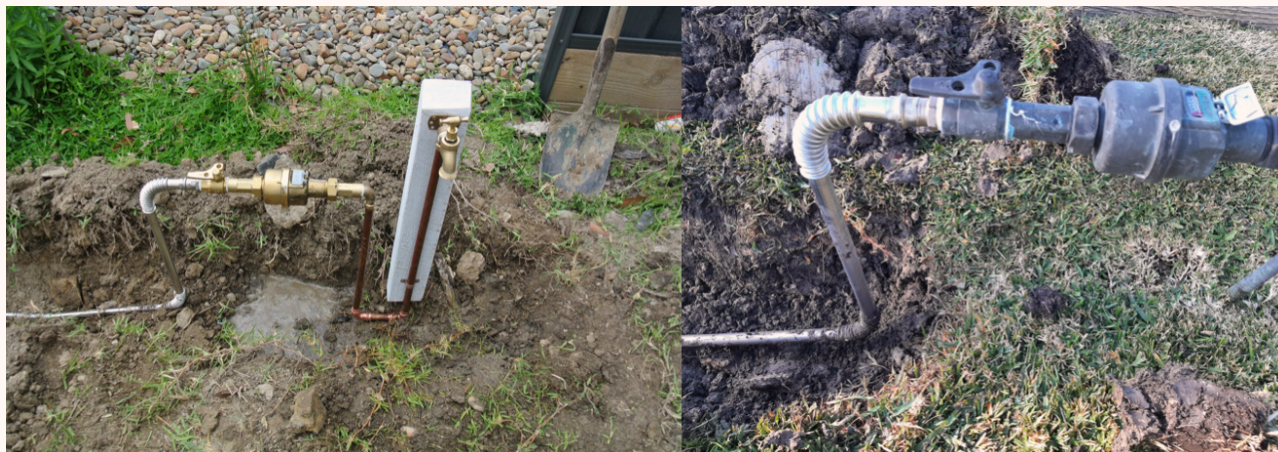
Figures 7 and 8 below show installation photos taken December 2018 and excavation photos taken after 3.5 years exposure in June 2022.

Figure 7: SPCT as installed, left, and right, exhumation after 3.5 years exposure. Note patina on copper alloy fittings (right) showing corrosive atmosphere present at site.

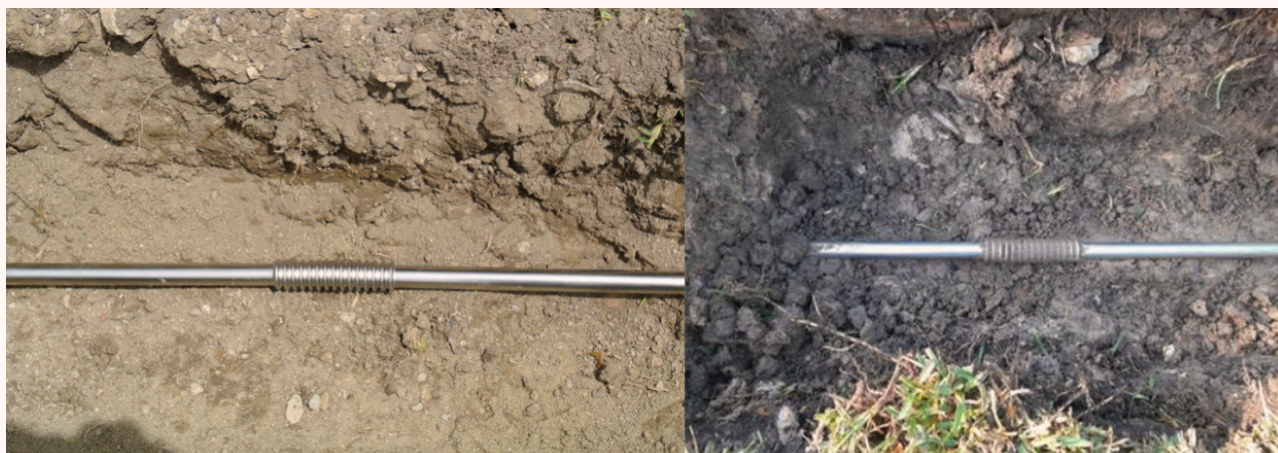
Figure 8: SPCT as installed, left, and right, exhumation after 3.5 years exposure. Note that stainless tube on right still bright and uncorroded despite burial in corrosive clay soil without granular backfill.

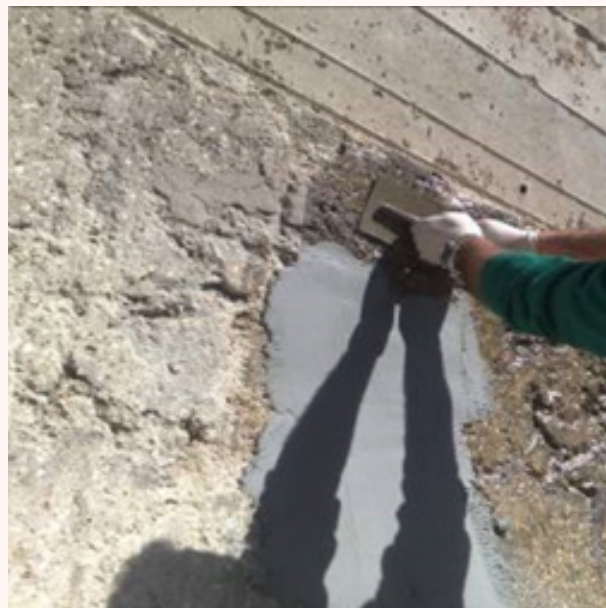
Fig. 1 Repair of Abrasion Damage on inclined Screw Pump trough

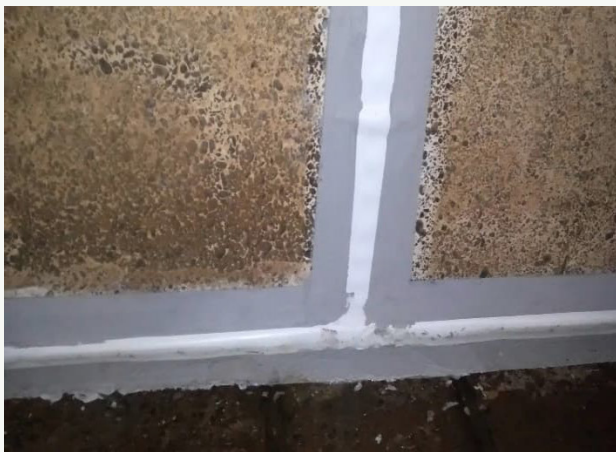
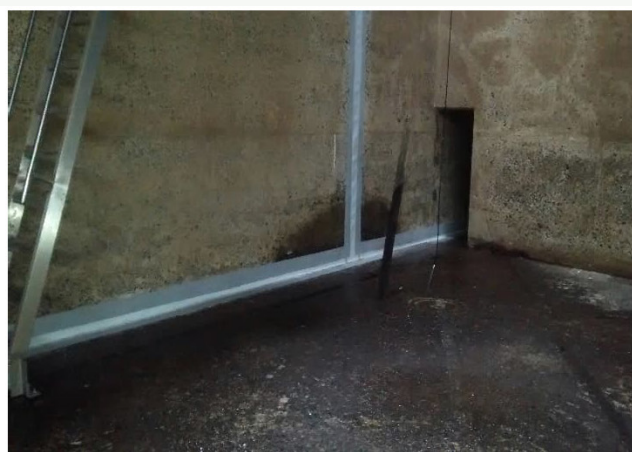
Hypalon Bandage system (bonded using epoxy paste) installed to vertical joints and wall/floor intersection.

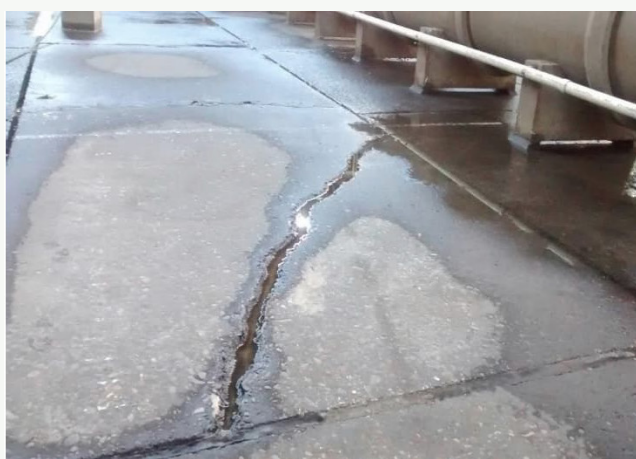
Cracks in existing concrete floor slabs

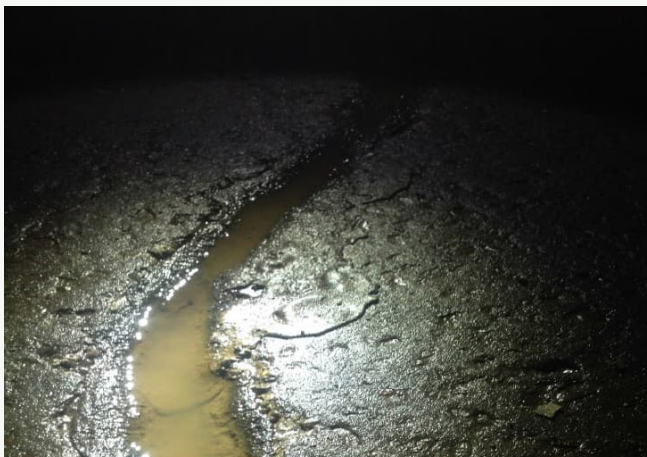
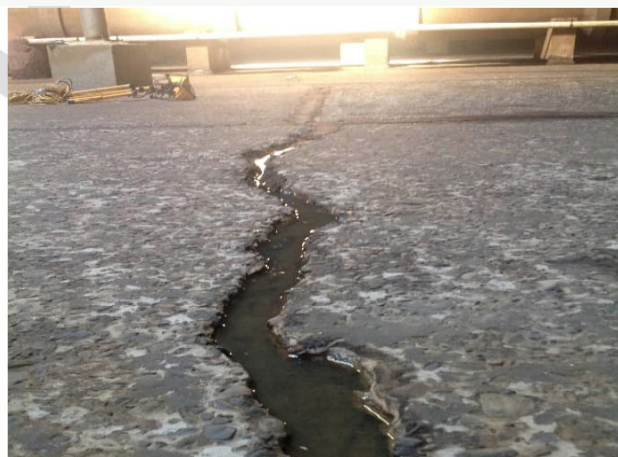
Generally cracks were full of water so the nominated system needed to be damp surface tolerant.

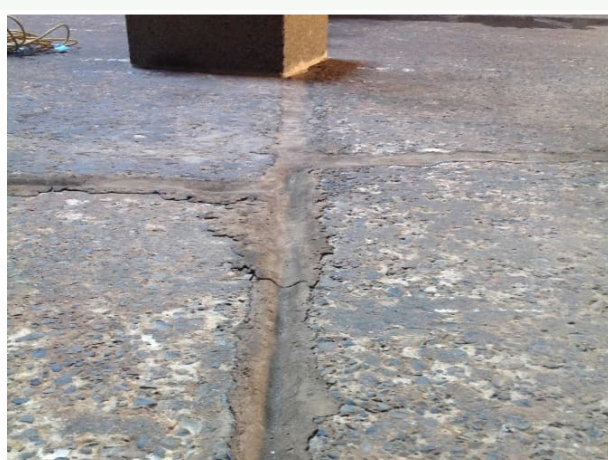
Generally cracks were full of water so the nominated system needed to be damp surface tolerant.

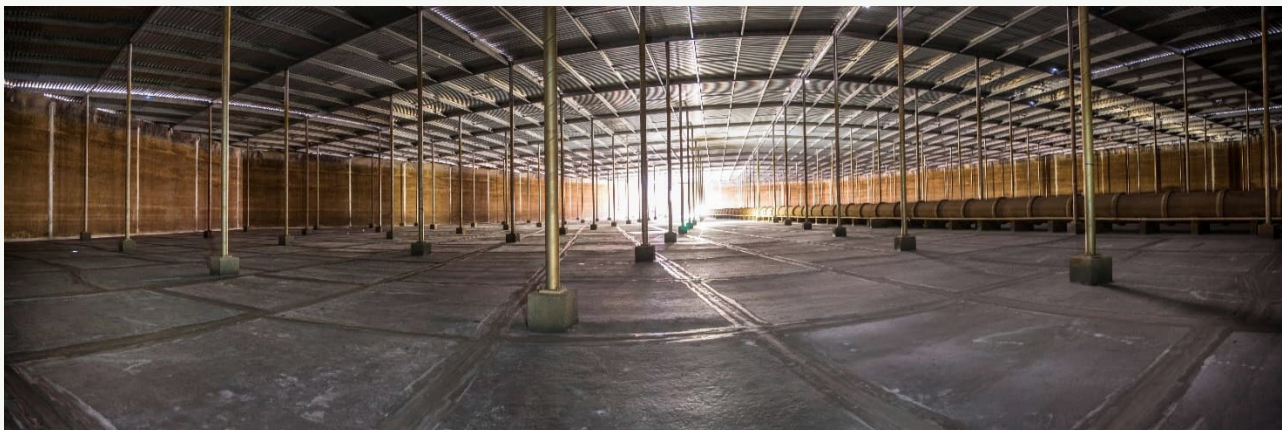
Panoramic photo of the installed waterproof coating.

The cementitious coating was mixed in bulk using a rotor stator pump and flow applied onto the concrete slabs. The applicator (McElligott Partners) was careful to ensure a wet edge was maintained on the material. The material was constantly checked for correct WFT (2mm) and immediately spiked rolled to remove any air that was entrained in the freshly applied coating.

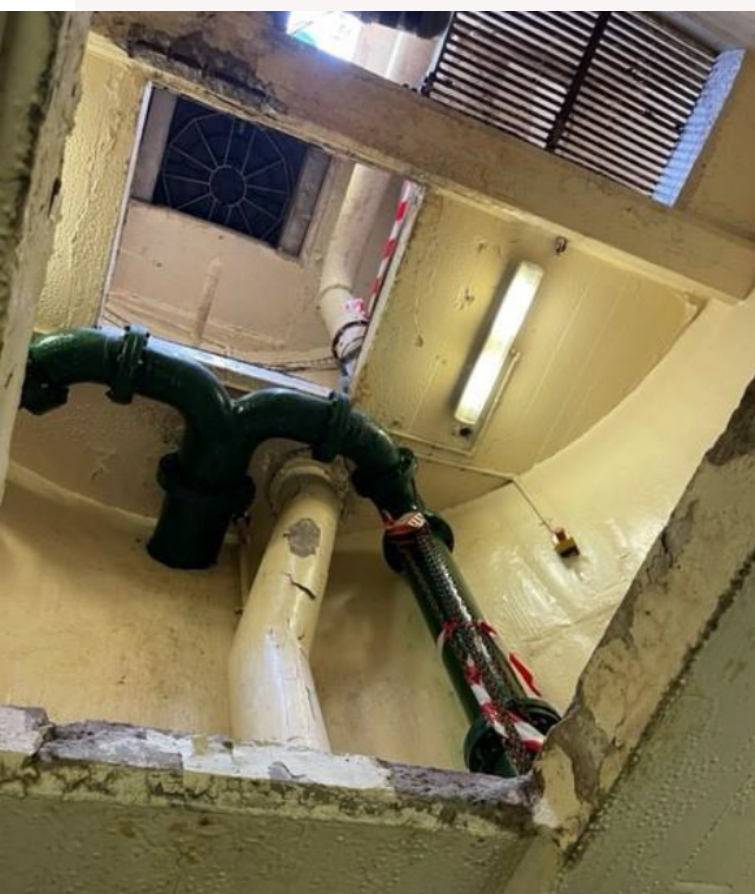
Figure 4 - Condition as viewed from within the well base

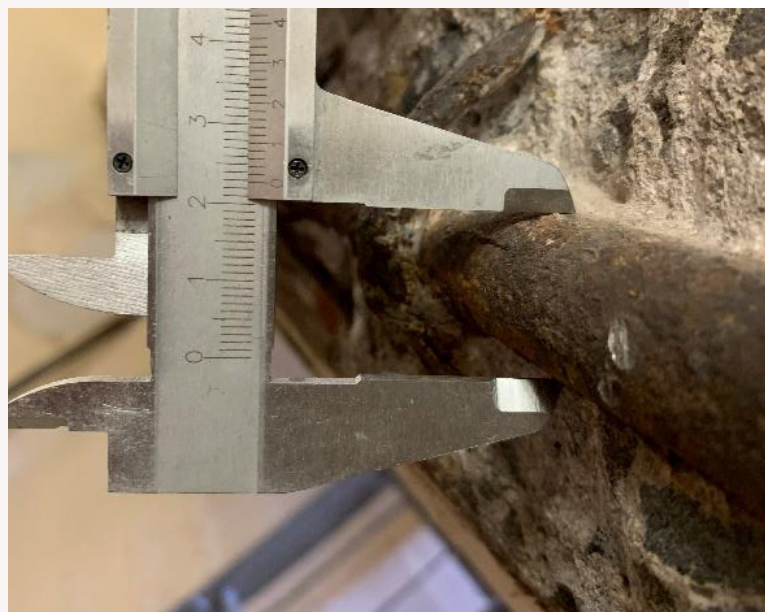
Figure 5 - Inspection Of Rebar At Areas Of Spalling

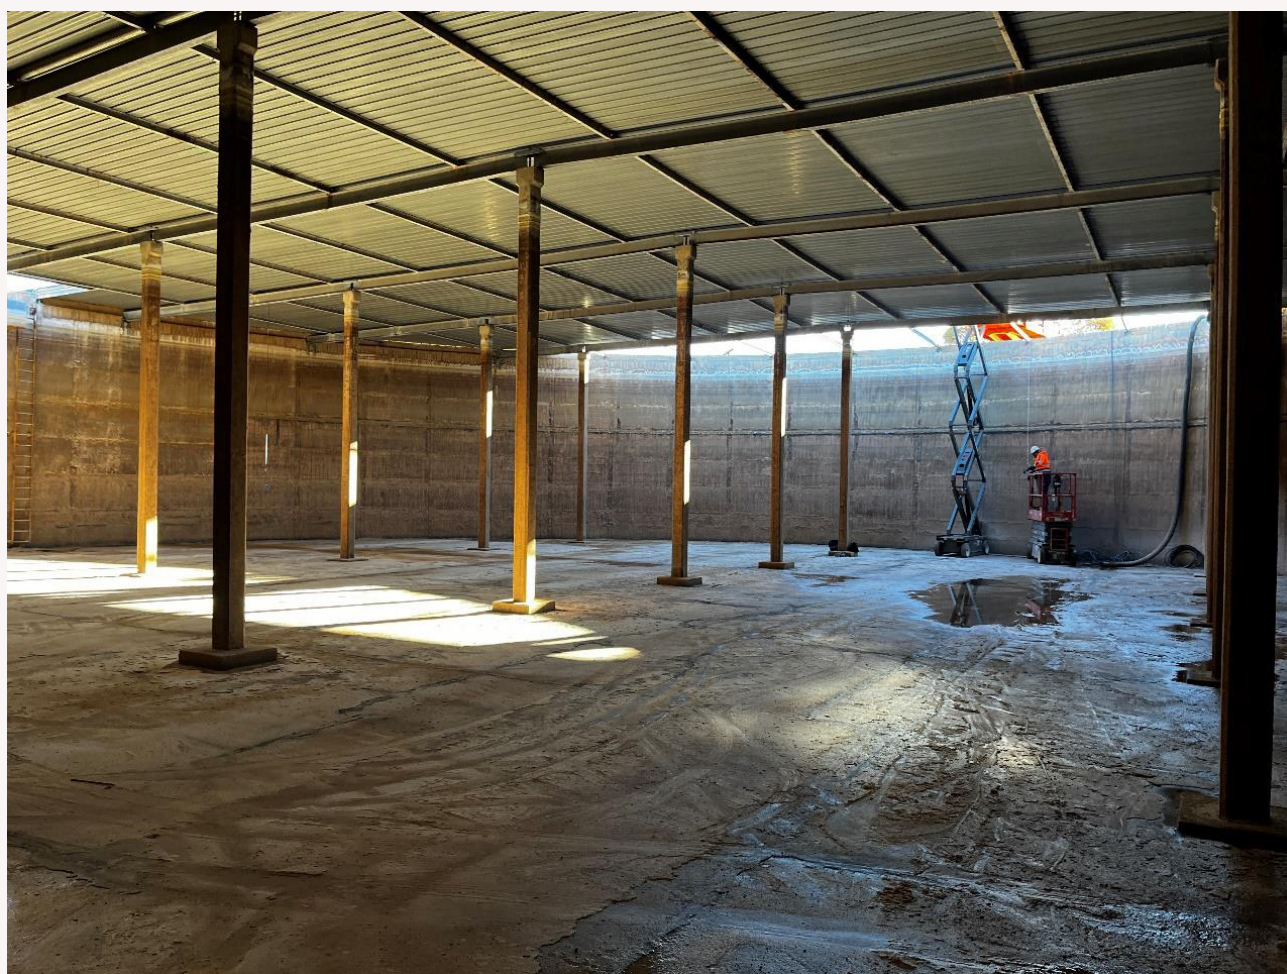
Figure 1 Typical reinforced concrete tank – internal

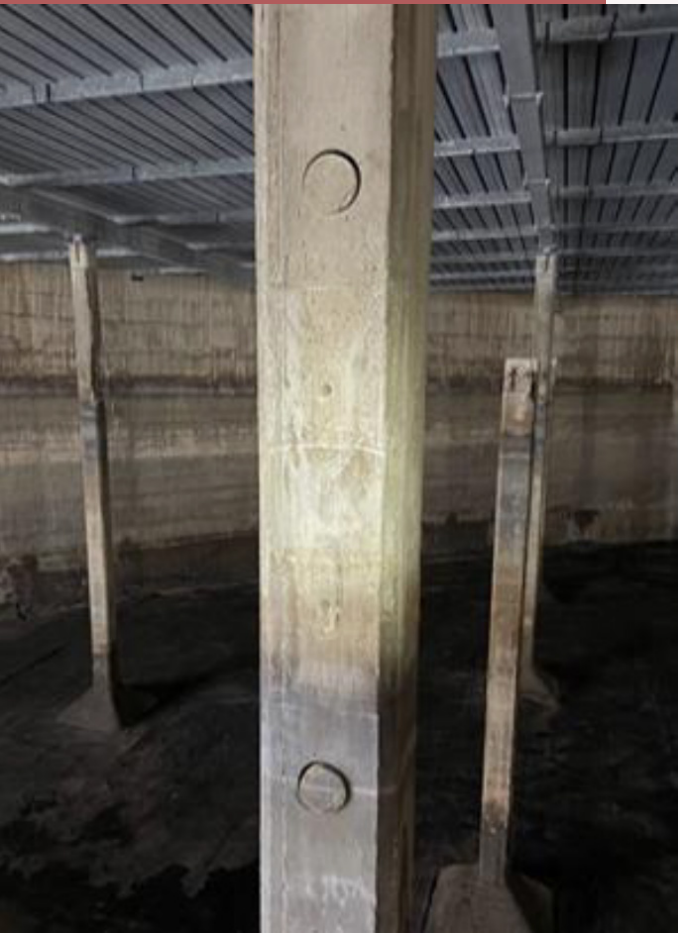
Figure 3 Example of cores taken locations below the water line and above the water line

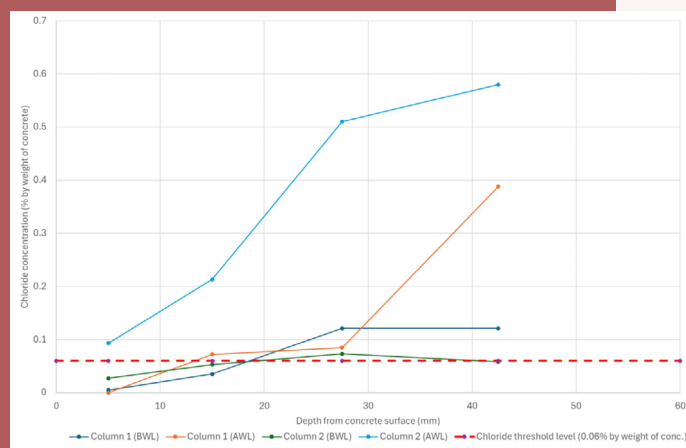
Figure 5 Chloride concentration profile results
