CORROSION

Vol 43 No 3, August 2018
ISSN 1326-1932

CONCRETE & CP FEATURE

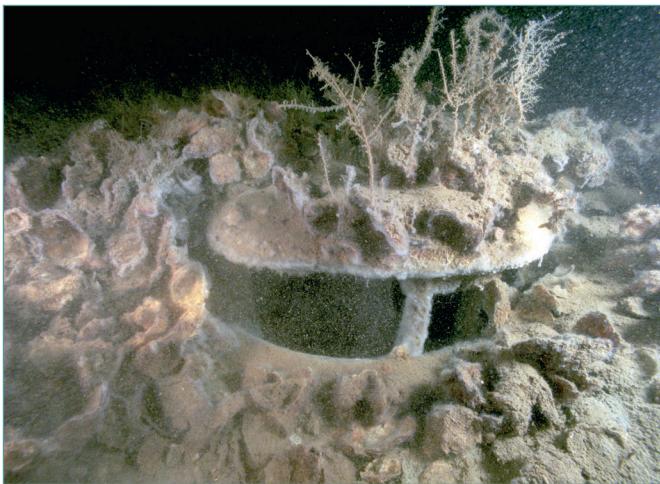
Figure 3: Hatch cover in partially open position showing 10 cm gap for taking the drop camera.

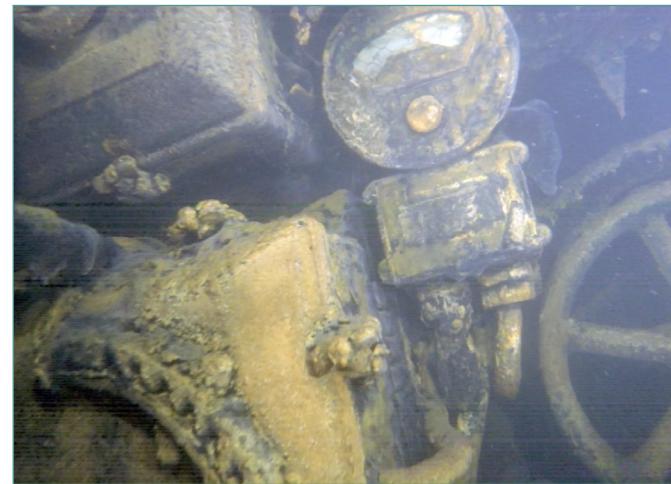
Figure 4: ROV mounted image of interior of control room after the main hatch had been opened.

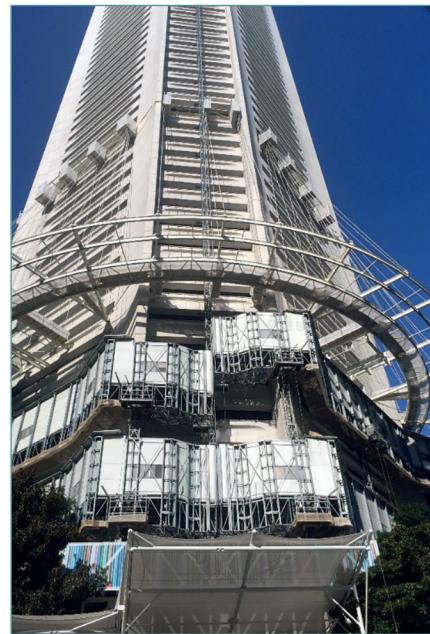
Figure 3 – Monorail Transfer of platforms between phase 1 and 2 of the project.

There were two main phases of the project: North side works and South side works. For transition of the access system from north to south, a 'Monorail Transfer System' (Figure 3) was designed and implemented whereby all 4 platforms would be transferred 180° around the perimeter of the building while suspended from a circular self-supporting structure anchored from the first plant room level located on Level 26. This system was implemented to drastically reduce the need for road closures and cranes, thus further minimising the impact of the overall works on the building occupants and public alike.

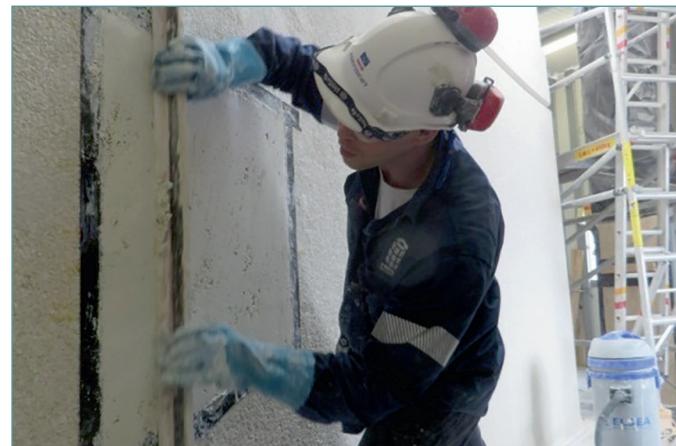
Figures 4 & 5 – HCP in process & concrete repair application of new mortar.

Repairs to the column panels were focused on the perimeter edges. Cracking located along the edges, or spalls at corners were identified and subject to approved design criteria, broken out and repaired. New reinforcement was added at these locations in the form of 6mm diameter stainless steel, drilled and chemically embedded to the surrounding precast panel and anchored to the concrete substrate. As with the spandrel repairs, specifically developed repair mortar mixed with white quartz aggregate (to match original panel finish) was poured in custom fitted formwork and allowed to dry. The form was stripped at a specified time to allow for the 'washing' of the surface laitance, thus exposing the quartz aggregate to achieve a uniform appearance.

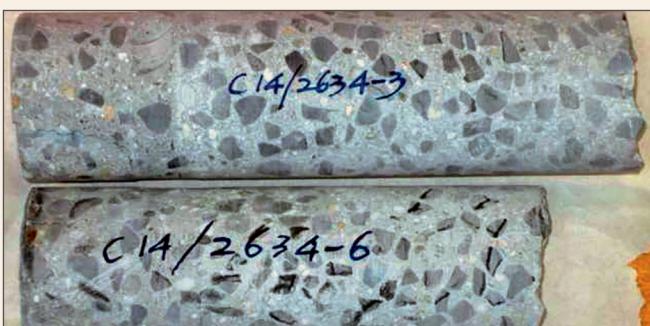
Cores of 95 mm diameter taken for residual expansion measurement: Core 2634-3 from pier wall; Core 2634-6 from abutment crosshead.

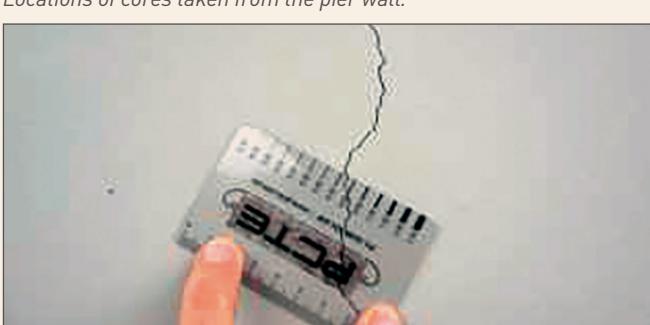
Crack (0.40mm) on north face of pier wall.

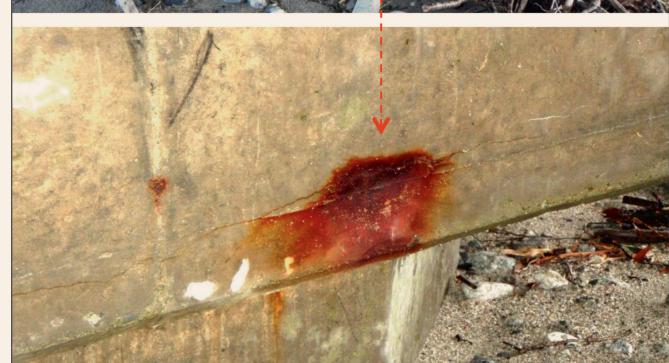
Spalling at base of the hammerhead on Pier C on the Fox River Bridge.

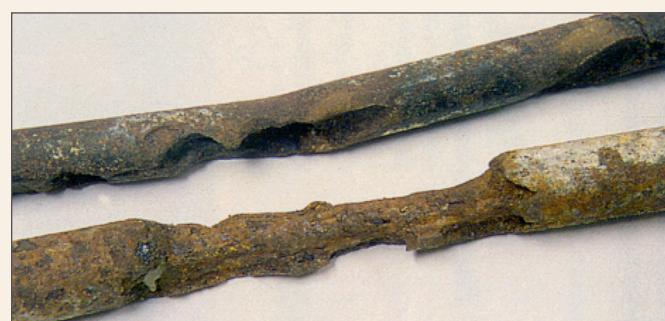
Figure 5. Example of marked localised pitting (macrocell) corrosion and section loss (corrosion penetration) of steel reinforcement. Here pits would have started out narrow but with time have coalesced to result in section loss over a greater (anodic) area.

It is most important to note however, that not all corrosion of reinforcement leads to rust staining, cracking, delamination or spalling of cover concrete. Localised pitting, localised corrosion at cracks, localised corrosion at concrete defects, etc can result in marked section loss (loss of bond, loss of anchorage) and ultimately structural failure without the visible consequences of corrosion on the concrete surface, i.e. no rust staining, cracking, delamination or spalling of cover concrete (Green et al, 2013). This form of decay is inherently more insidious. An example of marked localised section loss of reinforcement due to chloride induced pitting (macrocell) corrosion is provided at Figure 5. The definition of macrocell corrosion being as at Section 4.2 where a net distinction between corroding areas of the steel reinforcement (anodes) and non-corroding passive surfaces (cathodes) is found.

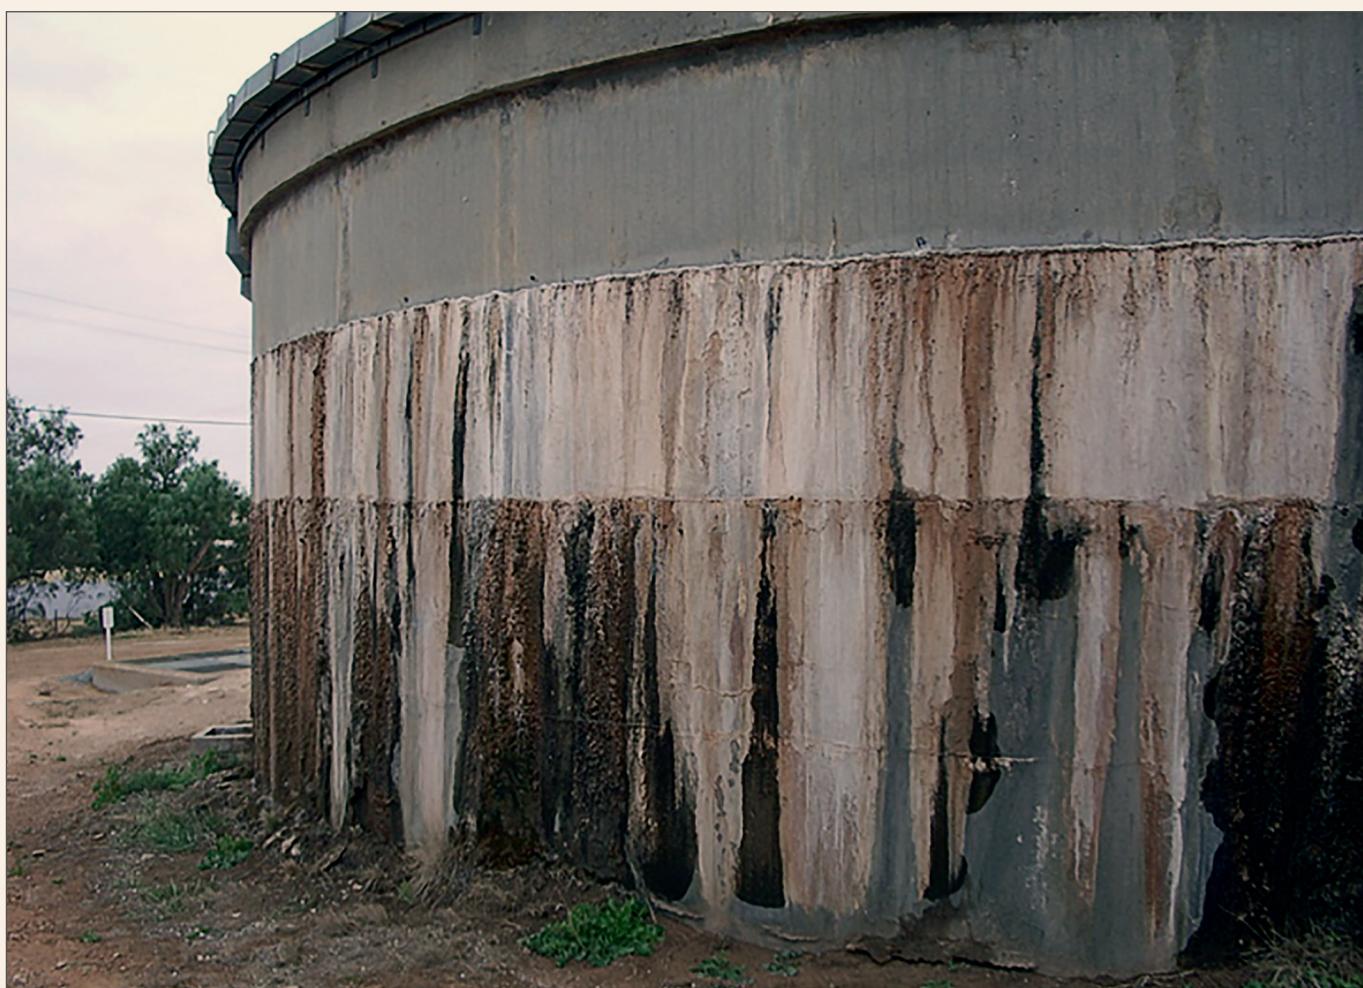
Figure 9. 'Black rust' (magnetite) localised corrosion of steel reinforcement due to leaching at construction joints in the wall of a reinforced concrete tank containing potable water. (Photo courtesy of Greg Moore)
