CORROSION

Vol 40 No 3, June 2015
ISSN 1326-1932

**Research Paper: Condition Assessment and Asset
Management of Water Storage Tanks**

Condition Assessment and Asset Management of Water Storage Tanks

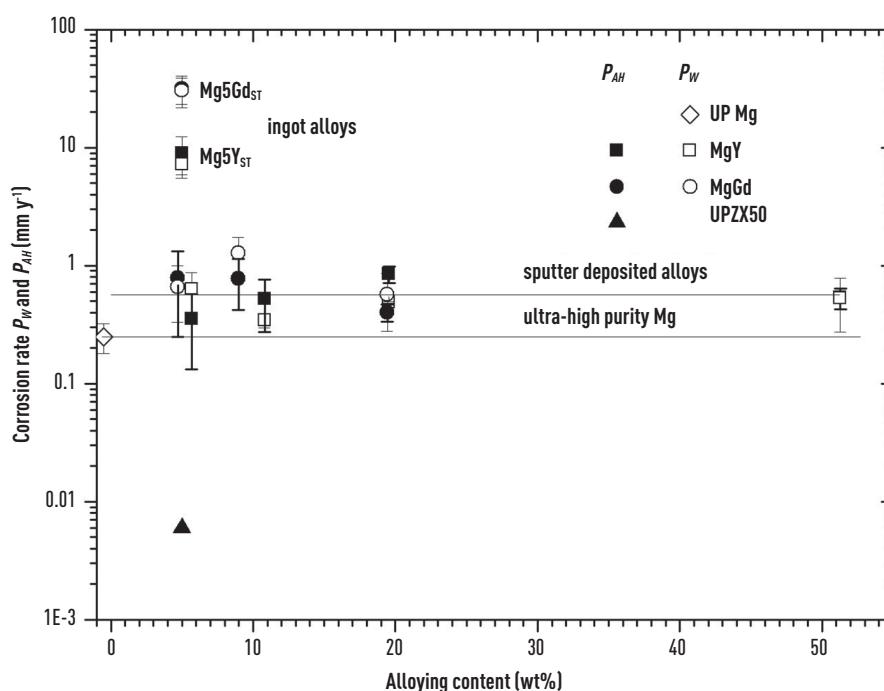
Figure 1. Low corrosion rates might be possible if it is possible to find a Mg-X alloy, which forms a protective surface oxide based on X rather than based on Mg as usually occurs for Mg alloys. This is analogous to an oxide based on Cr forming on stainless steels provided the Cr content is greater than 11%. That this might be possible is shown by the corrosion rates of the sputter-deposited alloys {MgY (squares) and MgGd (circles)}, which were comparable with those of ultra-high-purity (UP) Mg (diamond) and much lower than those of the ingot-metallurgy solution-heat-treated alloys {Mg5Gdst (circles) and Mg5Yst (squares)}. All the alloying elements were dissolved in the Mg matrix for the sputter deposited alloys, whereas the ingot alloys contained second phases which accelerate the corrosion rate by micro-galvanic coupling. The intrinsic corrosion rate for ultra-high-purity Mg is $P_w = 0.27 \pm 0.07 \text{ mm y}^{-1}$. Corrosion rates in 3.5 % NaCl solution saturated with $\text{Mg}(\text{OH})_2$, were evaluated from average hydrogen evolution rate, P_{AH} (closed symbols), and weight loss, P_w (open symbols). The corrosion rate of the ultra-pure alloy ZX50 is also plotted. For more information please see references [1,4].

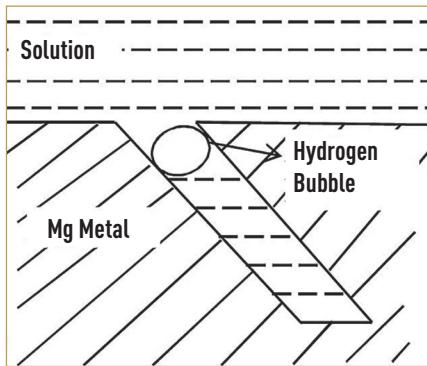
Figure 2. An idealisation showing how corrosion inside a crevice can be isolated from the solution by the evolving hydrogen, so that such corrosion cannot be measured by any electrochemical measurement. For more information please see reference [1].

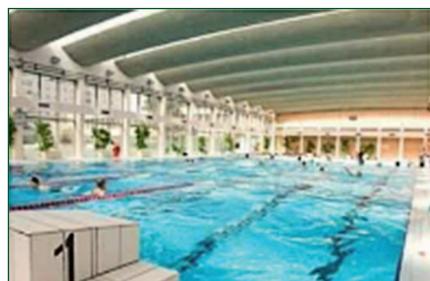
The structure was built in 1972 and the roof is composed of independent prefabricated prestressed concrete shells.

Prefabricated Prestressed Concrete Shell Roof Construction.

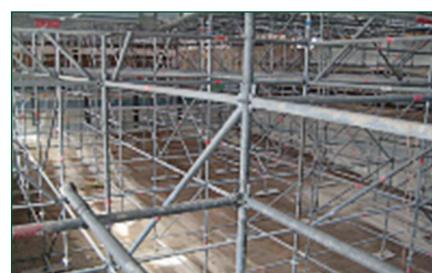
Scaffolding access was erected to provide adequate access to allow working on all of the beams simultaneously from the internal and external structure and provide for the collection of waters from surface preparation water jetting.

Internal Access Scaffolding.

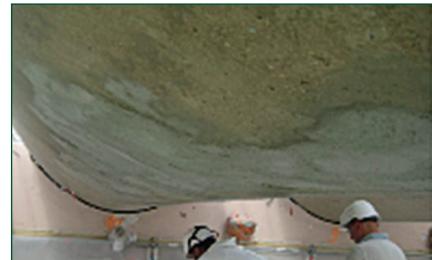
Concrete Patch Repair.

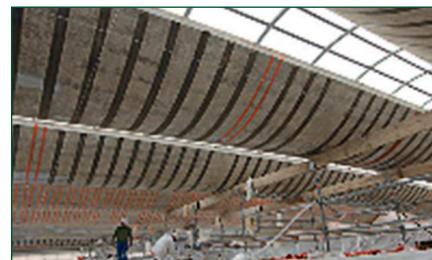
Carbon Fibre Strengthening.

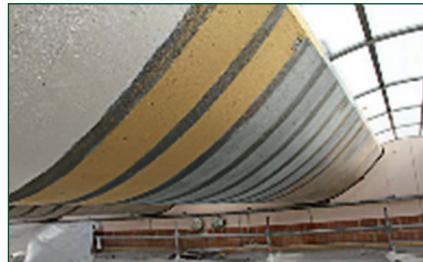
Applied Waterproof Membrane.

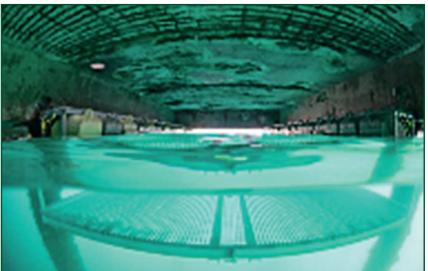
Submerged Platform Access.

Access to the work areas was difficult and achieved through a combination of submerged platforms and rope access.

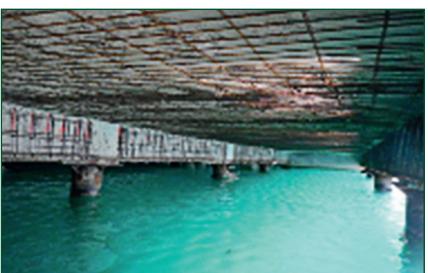
Concrete Removal and Rebar Replacement.

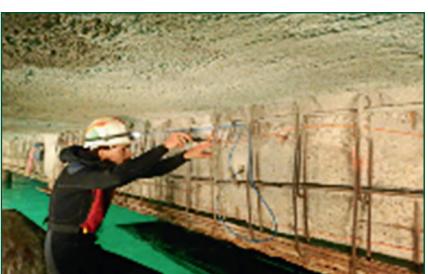
Conductor Installation.

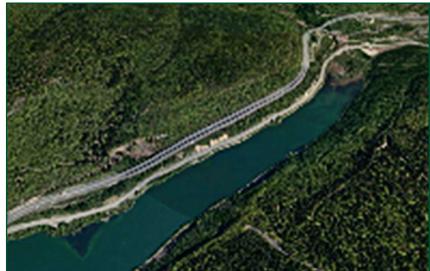
Sylans North and South Viaducts.

The poor design of drains and water harvesting seals and the lack of maintenance over time have provided a path for water loaded with road deicing salt to come into contact with and degraded reinforcement embedded within the concrete piers and footings of these structures causing heavy damage to the reinforced concrete.

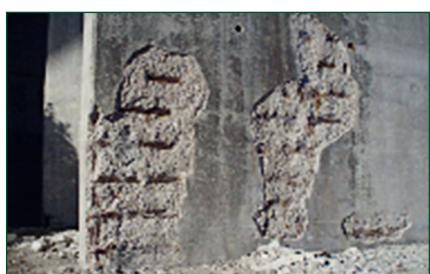
Corroded and Degraded Reinforcement.

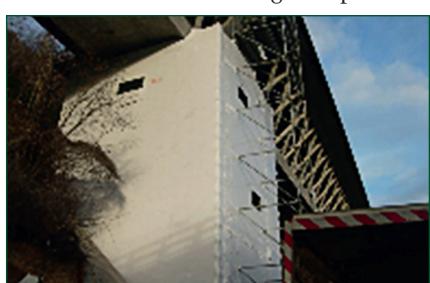
The geographical location of the structure presented challenges with harsh winters yielding snow and freezing temperatures. The scaffold was fully sheeted and heated to undertake the remedial works during cold periods.

Sheeted and Heated Scaffold.

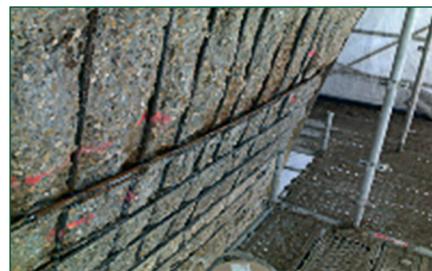
Hydro Demolition and Rebar Replacement.

The works undertaken included the hydro demolition (600m^2) of the main siding, the provision of an interim stability study, reinforcement replacement, dry shotcrete repair, installation of drilled titanium anodes, expanded titanium mesh and strip expanded titanium ribbon anodes.

Following the completion of the hydro demolition stage of the works a study for structural stability was undertaken prior to the replacement of missing or badly corroded reinforcement.

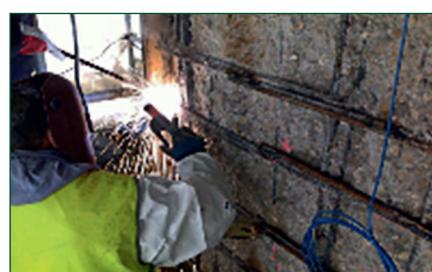
Electrical continuity of reinforcement was checked prior to the placement and installation of anodes and reference electrodes and associated electrical wiring.

Anode & Reference Electrode Installation.

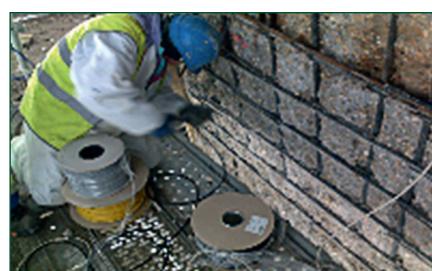
Titanium Ribbon & Anode System Placement.

The titanium ribbon and anodes were then installed to the structure prior to the trowel finished application of the finishing mortar to an area of 600m^2 .

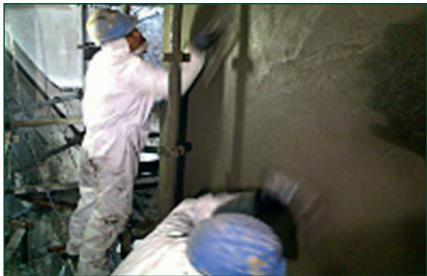
Trowel Finishing of Shotcrete.

Siding reconstruction was completed by dry shotcrete process over an area of 600 m^2 .

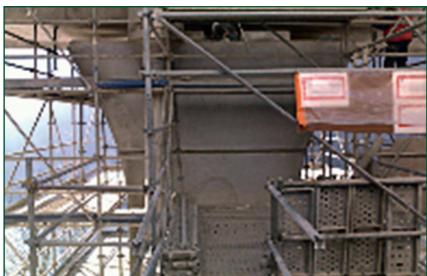
Completed Remediation.

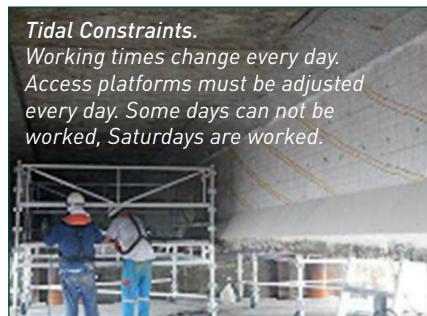
Tidal Constraints.
Working times change every day.
Access platforms must be adjusted
every day. Some days can not be
worked, Saturdays are worked.

When high tide level is reached the beams of the structure are immersed in the water. With these access restrictions prevalent, the available working

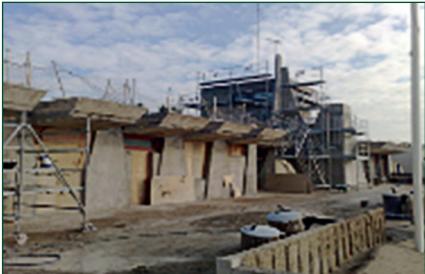
Surface Preparation by HP Water Jetting.

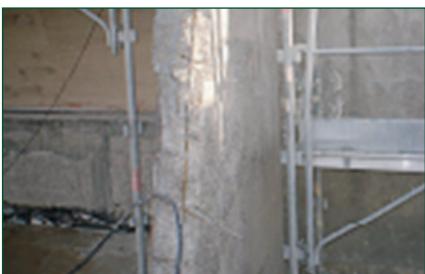
Defective Concrete Removed & Remediated.

with a polymer-modified high build repair mortar prior to the application of the thermally sprayed zinc system.

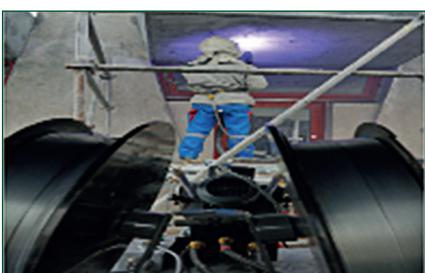
Thermal Spray Applied Zinc CP System.

The selected galvanic protection system consists of a plasma torch applied layer of zinc to the concrete which is linked at intervals to the reinforcement by a system of stainless steel plates and rods in order to act as an anode. A pore-blocking coating is applied after the metal spraying operation, making it possible to apply a coloured finishing coat. This system is designed for use on structures built on the seafront in particular and is capable of providing protection for over 30 years. It is especially suitable for concrete structures for which the corrosion currents are moderate and can also be applied to new works as corrosion preventive protection.

Checking the thickness of the applied zinc layer was undertaken using a dry film thickness gauge with nominal thickness of 315 microns recorded.

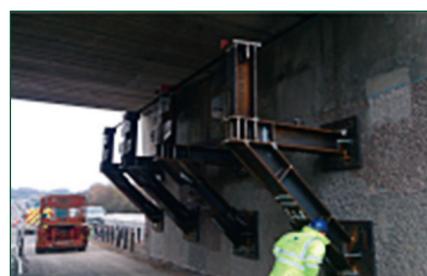
Temporary Support & Jacking Placement.

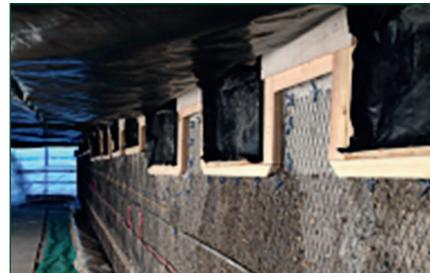
Several processes were undertaken on 24 hour working roster to maintain the client's programme such as the design, supply and erection of the access scaffolding, the design, supply and installation of new elastomeric bearings in accordance with client design requirements, the design, supply and installation of a cathodic protection system and the application of sprayed concrete overlay to the treated areas. The design of the cathodic protection system included the installation of a mesh and overlay impressed current system.

Mesh Overlay CP System.

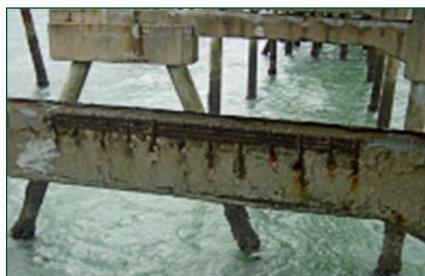
Prior to cathodic protection system installation concrete repairs were undertaken. Firstly a detailed survey was completed and damaged concrete was removed by hydro-demolition. Repairs were made using dry mixed sprayed concrete. Cathodic protection to the concrete reinforcement was achieved using a titanium mesh anode in an overlay of sprayed concrete. Additionally, impressed current water anode cathodic protection was provided to protect underwater concrete and steel piles.

Corroded Rebar & Degraded Concrete.

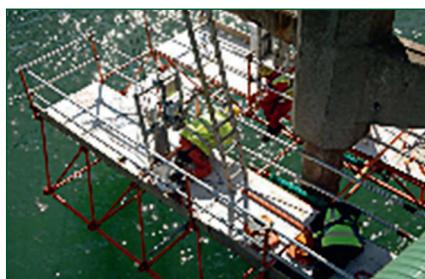
Access System to Piles.

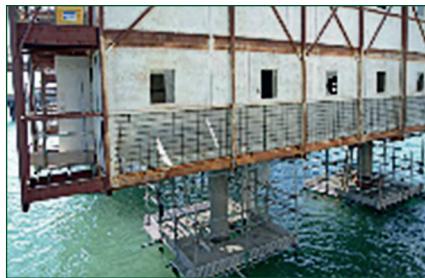
Encapsulation of Headstocks.

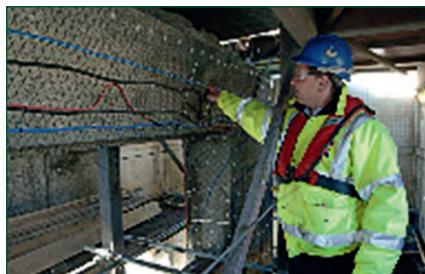
Titanium Mesh Installation.

The completed project works provides for 12,000m² of concrete protected by titanium mesh cathodic protection and sprayed concrete overlay in 147 anode zones comprising 880 reference electrodes to monitor performance, 342 submerged anodes and 227 submerged reference electrodes.

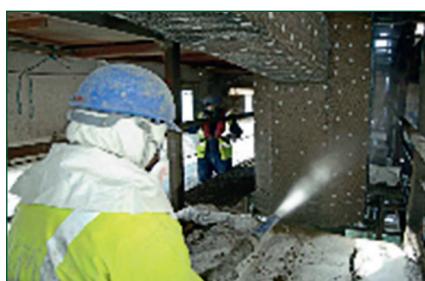
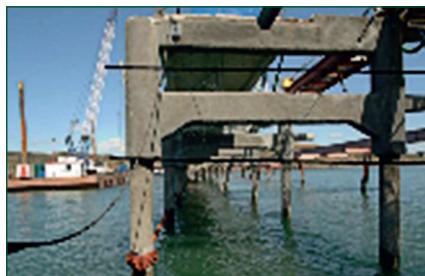
Sprayed Concrete Application.

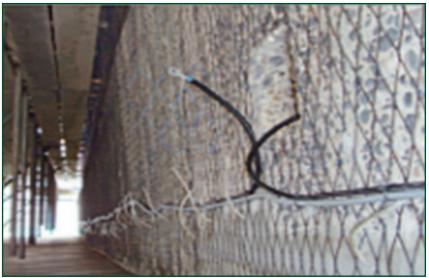
Installation of Impressed Current CP System

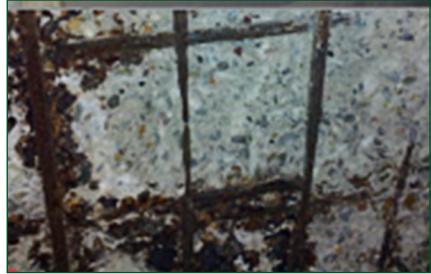
Corroded Rebar & Degraded Concrete.

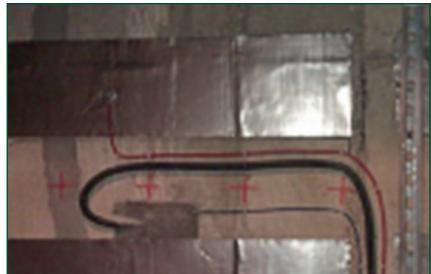
The project was completed in two stages. The break out and removal of delaminated and spalled concrete was followed by testing to ensure continuity of the reinforcing steel prior to the completion of concrete repair works. The repair areas were allowed to cure prior to the installation of a ZLA "sticky zinc" galvanic cathodic protection system. The locations of zinc were marked out on the walls and soffit with small pockets broken out to allow for the welding of studs to the reinforcement before being electrically connected to the ZLA.

Galvanic Cathodic Protection System.

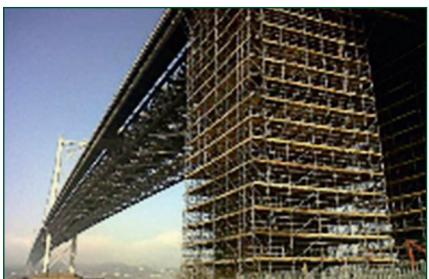
The remediation works needed to be completed with no disruption to traffic using the bridge which necessitated the need to design special access systems.

Forth Road Bridge Access System.

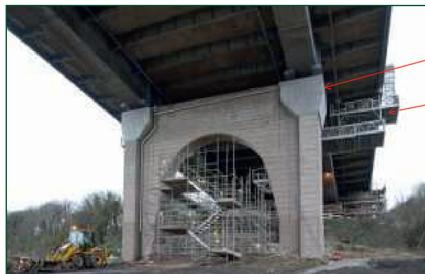
The corbels were required to carry the load from the temporary jacks to allow the permanent bearings to be replaced whilst also allowing the pier top concrete to be broken out and recast where needed to rectify the

deterioration. For this reason, the corbels were cast 300mm below top of pier level so that pier top breakout would not undermine the new corbel reinforcement.

Corbel addition within clearance of the inspection gantry.

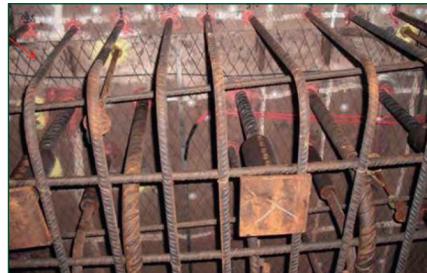
Titanium mesh based anode to be installed at the interface of concrete substrate and new corbels.

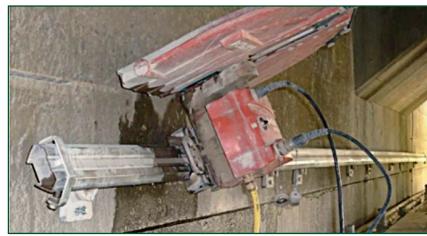
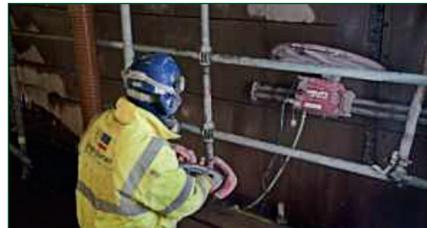
Titanium ribbon based anodes to be installed within slots cut into the concrete cover.

An innovative technique was designed that utilised a special chase cut into the concrete using a remote operated wall saw. This cut up to 60 metres per day without exposing operatives to excessive hand arm vibration or concrete dust.

Over 14,000m of titanium ribbon anode strip was installed into the concrete faces of the pier head, cross beams and legs to form part cross beams and legs to form part of the CP system.

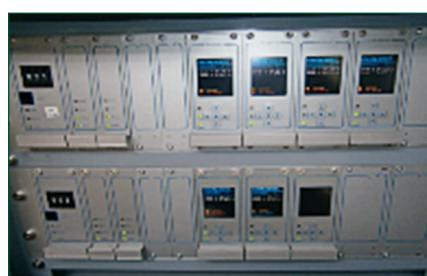
The area covered by each anode zone was designed to be independently powered by an integrated power supply and data acquisition unit, which will provide the facility for controlling the voltage and current to each zone; and monitor/control each zone; and monitor/control the performance of the CP system.

All units are installed within two networks (one for each approach viaduct). On each network all units were detailed to be operated from a single main control unit either locally on site or remotely via a modem connection.

Integrated Power Supply & Data Acquisition Unit.

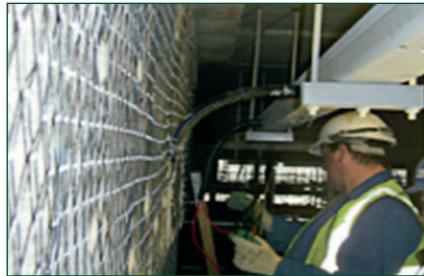
System Cable Installation.

Due to the variation in exposures the cathodic protection system utilised three different anode systems, embedded discrete anodes for atmospherically exposed slender columns, expanded mesh anode and concrete overlay for beam and skirt structures and a series of submerged anodes for the seawater submerged structures.

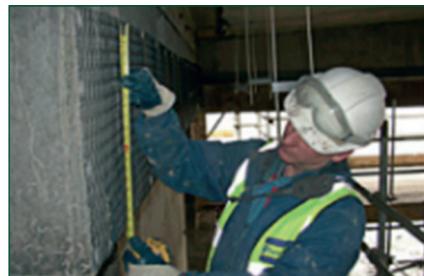
System Anode Mesh Installation.

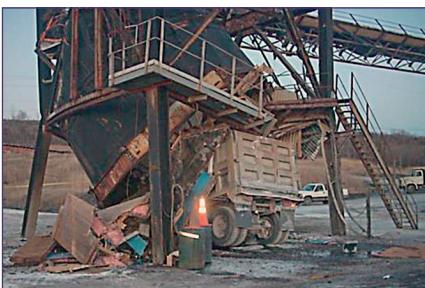
Figure 1. Collapse of steel salt bin in US that killed a truck driver. The road salt bin structure failed due to corrosion.

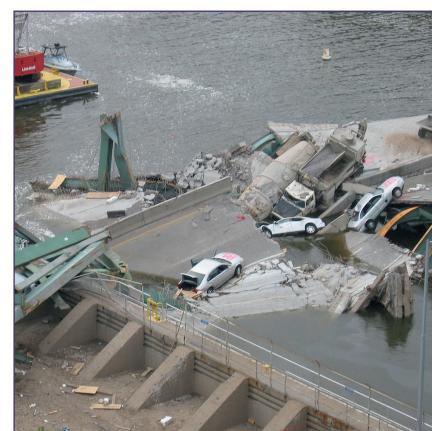
Figure 4. Minneapolis interstate highway bridge I-35W collapse in 2007.

In 1993 bridge I-35 was given a rating of structurally deficient because of corrosion in the steel expansion bearings. Because the deck bearings were not sliding bearings, bridge inspectors concluded that the corrosion observed was not a major issue. Some repairs to fatigue cracking and steel joint corrosion were carried out during the late 1990s and the bridge inspection level was increased thereafter. As late as 2006 a full bridge condition inspection raised no immediate concerns about the bridge condition. The worst nightmare of any bridge engineer occurred shortly after the 2006 inspection when the steel truss bridge failed catastrophically (Figure 4).

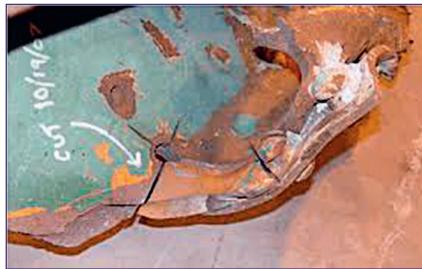
Figure 5. Bridge I35W steel gusset plate showing cracking and corrosion [7].

In 2008 the US National Transportation Safety Board (NTSB) released initial forensic findings on the bridge failure regarding the areas of load capacity, design issues, computer analysis and analysis of undersize corroded gusset plates. The forensic investigation revealed that photographs taken during a 2003 inspection of the bridge showed some corroded gusset plates were bowing. The root cause of the bridge I-35 failure was later found to be primarily due to undersize gusset plates which were only 13mm steel thick (Figure 5). This was a structural design fault.

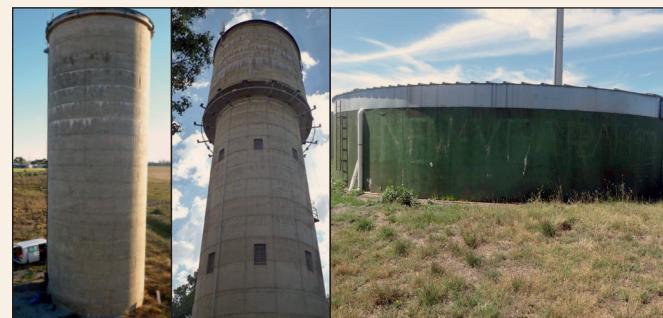
Figure 1 Typical reinforced concrete water tanks inspected as part of this case study.

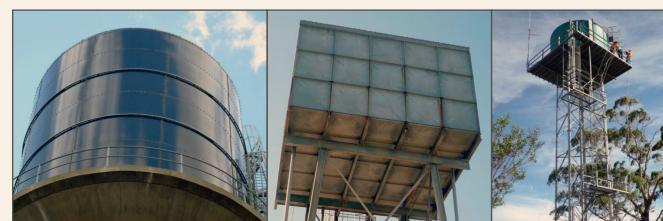
Figure 2 Typical steel water tanks inspected as part of this case study.

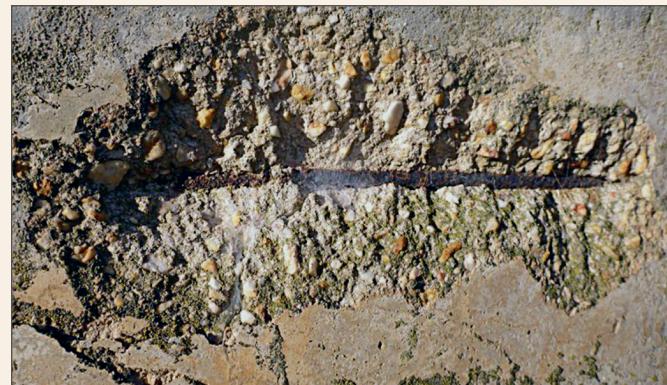
Figure 3 Reinforcement corrosion resulting in spalling concrete on external tank wall.

In most cases, concrete cracks were not considered to be the limiting factor with respect to remaining structural life of the tanks, however reinforcement corrosion resulting from cracks was expected to result in continued deterioration which could be more expensive to repair in the future than undertaking less extensive minor repairs when identified. Water leakage at cracks and defective joints is undesirable for serviceability reasons and, if leakage rates are high, for operational reasons.

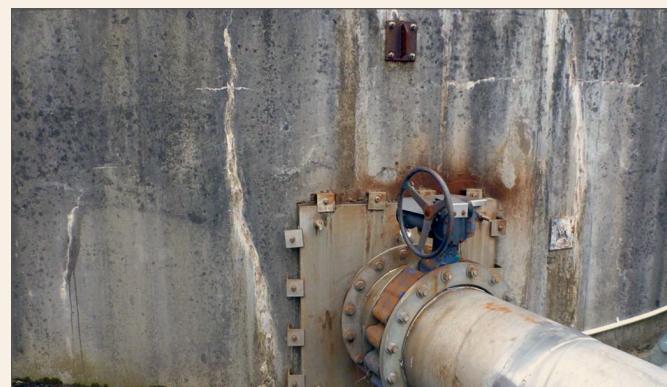
Figure 4 Cracking caused by early age thermal restraint in a reinforced concrete tank.

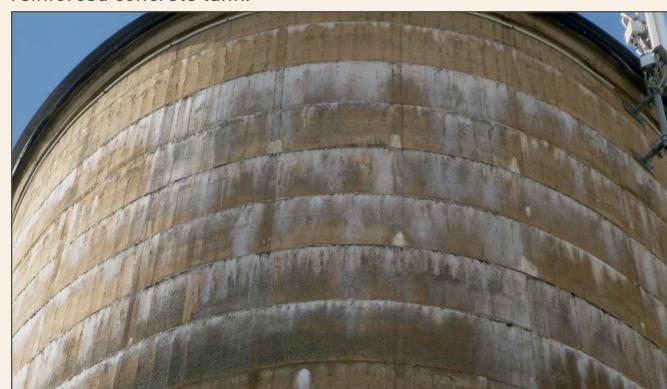
Figure 5 Water leakage and efflorescence at horizontal construction joints.

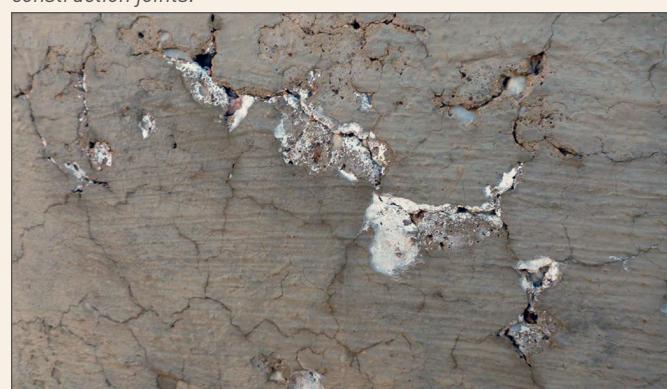
Figure 6 Suspected AAR cracking of concrete water tank constructed from locally sourced aggregate.

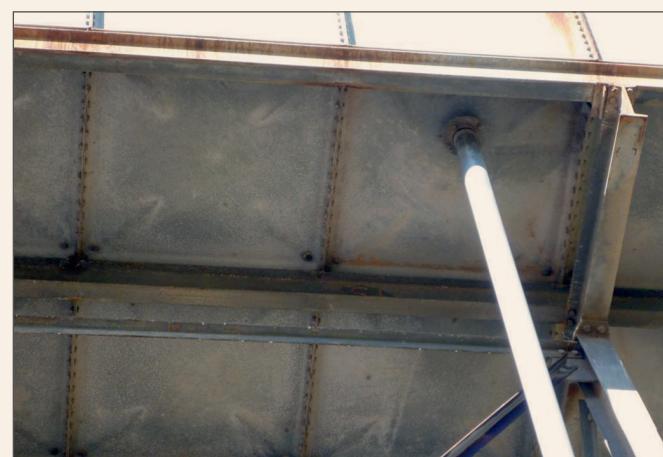
Figure 7 Atmospheric corrosion of galvanized coating, accelerated by the micro-environment on the underside of the tank (condensation, sun exposure etc.).

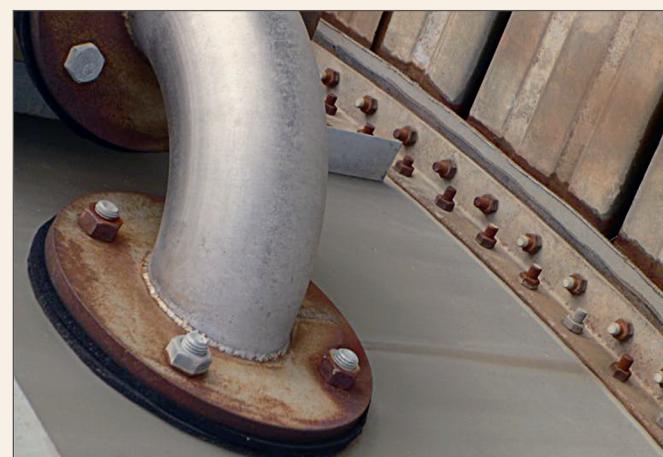
Figure 8 Dissimilar metal corrosion of a mild steel flange plate that is welded to a stainless steel pipe. Pipe appears to be insulated from the tank.

Dissimilar metal corrosion [7], which could be considered an obvious corrosion risk, was found to be a surprisingly common deterioration mechanism in the tanks inspected. Welding of stainless steel pipes and ladders to galvanized or mild steel tanks results in preferential corrosion of the galvanized or mild steel. One example is shown in Figure 8. This effect was amplified where the tank was coated internally and accelerated corrosion occurred at coating defects due to the large cathode, small anode effect.

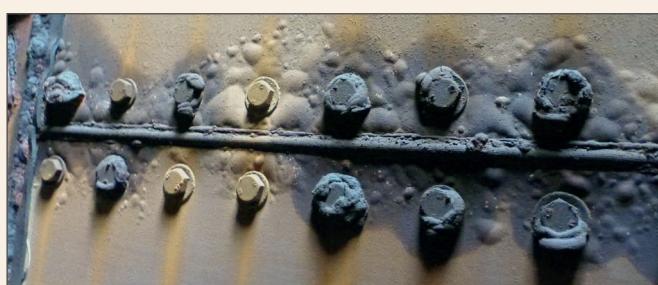
Figure 9 Blistering of internal coating at plate edges / bolt holes following immersion service.

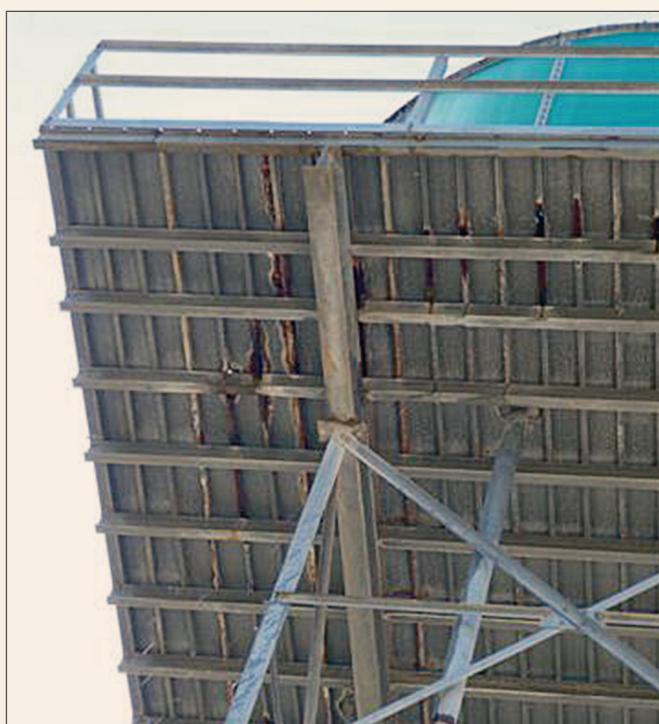
Figure 12 Corrosion of tank stand platform sheeting.

No structural analysis was undertaken to determine the level of steel loss allowed for by the design, however at the rates expected, surface rusting of the tank stand was considered a good early warning of an imminent durability risk.
