DECEMBER 2023 Volume 66, Issue 11. Online: www.corrosion.com.au

STRAY CURRENT CORROSION AND PREVENTIVE MEASURES

by Grant Chamberlain, CPNZ

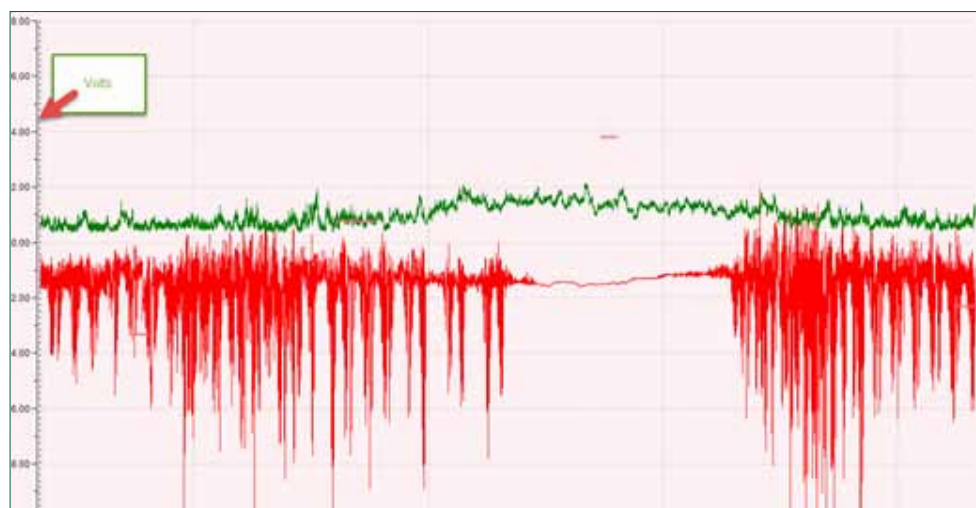
At right is an example of the stray current caused by the DC rail system in Wellington.

The smoother section is at night, when there are no trains running.

Stray current corrosion will only affect metallic structures, typically pipelines, in an electrolyte (buried in soil or immersed in water). Generally, the longer the structure, the more susceptible the structure is.

So long as structure 1 is the “path of least resistance” back to electrical earth, there is generally no problem. But if structure 2 is the path of least resistance, the current will jump off 1 and onto 2 at a coating defect, then at another coating defect it will jump off 2 to get back to 1, or directly to electrical earth.

Corrosion occurs when the electrical current arrives at and/or leaves a structure through the electrolyte (soil-water). The steel at a coating defect where the current leaves the structure loses electrons and will corrode i.e. the steel (Fe) turns into rust (Fe++) because electrons (e-) have been lost.

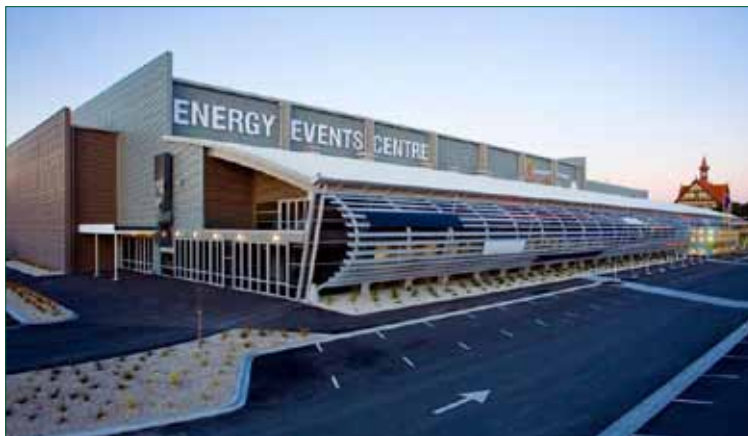
Corrosion has damaged the 'fins' of the façade and

the steel structure that holds them to the building. It would have cost \$200,000 to repair and replace the metal fins, which are not purely for aesthetics as they help shield the windows from the sun.

Who among us in the corrosion community was surprised at the Rotorua Daily Post article on 11 November telling us that Rotorua councillors had decided to spend \$40,000 to remove the distinctive - but corrosion-damaged - metal "fins" from the facade of the Energy Events Centre at Sulphur Point (a spot well-known for geothermal activity), opened in 2007?

The article says steel had been used on parts of the Energy Events Centre where aluminium should have been used, and that there had been flow-on effects on the cost of maintaining the building – including replacing the roof after 10 years.
